Geomorphic Impacts of the
2013 Colorado Front Range Flood
on
Black Canyon Creek and North Fork Big Thompson River

Chelsey DeWitt

University of Washington
March 9th, 2016

MESSAGe Technical Report Number: 032

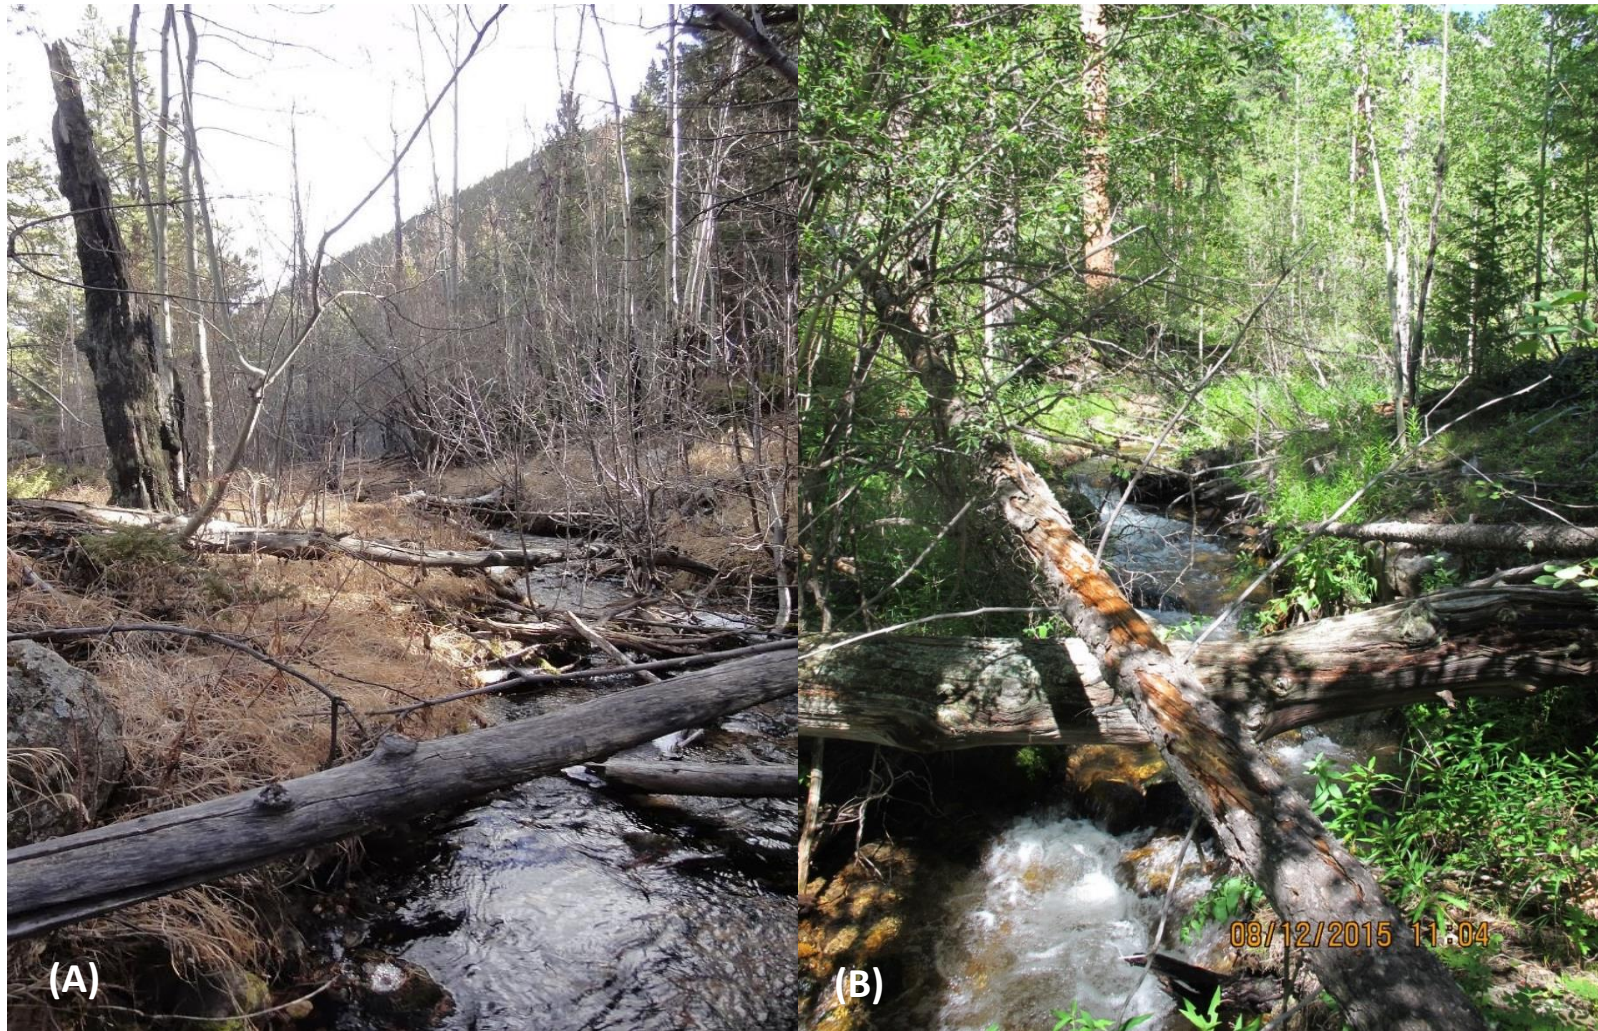
Before the flood, and subsequent debris flow, BCC had a diverse riparian zone of grasses, shrubs, aspen (*Populus tremuloides*), ponderosa pine (*Pinus ponderosa*) and lodgepole pine

Pinus contorta) (Figure 3). The upper portion (the first 11.5 kilometers) shows little flood impact, lacking evidence of bank failures and lateral erosion on 2001 Google Earth imagery. The middle portion of the watershed was inundated in 2013 by a total of three debris flows (Ryan, 2015) (Figure 2). The longest and more destructive debris flow, Debris Flow 1, appears to originate from a colluvium hollow failure along MacGregor Mountain and travelled 1.8 kilometers before reaching the main stem of BCC from the right bank. Deposition at the confluence of the debris flow and BCC includes a mixture of wood debris and boulders, as well as adjacent scour (Figure 4). The channel portion just below the debris flow appears to be scoured up to 10 meters (Ryan, 2015). Scour and deposition continues throughout the entire study area (Figure 5).

Figure 3. Images of Black Canyon Creek. A) Black Canyon Creek in January 2013 before debris flow inundation (Andy, 2013). B) Black Canyon Creek above the debris flow confluence at the reference cross-section as of August 2015.

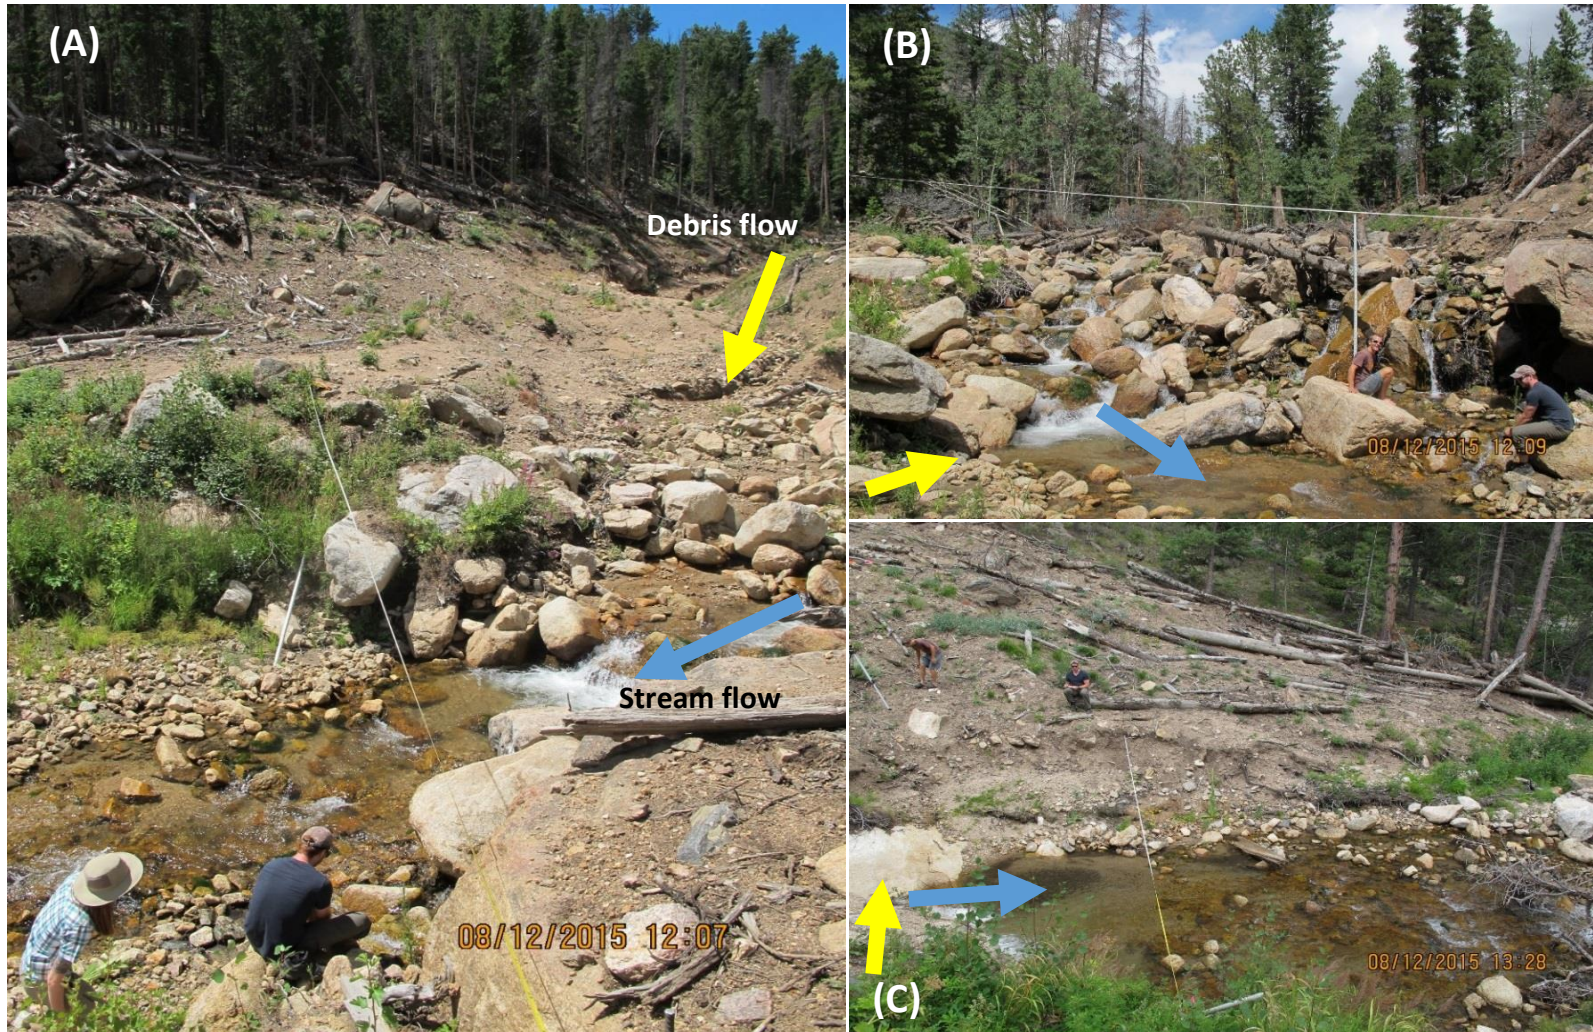
Figure 4. Debris flow and river confluence images for Black Canyon Creek taken August 2015. A) Taken from the left bank, looking across BCC towards the debris flow channel. B) Looking upstream at BCC at the large clasts and wood accumulation at the stream and debris flow confluence. C) Taken from the right bank of BCC at the stream and debris flow confluence facing towards the left bank.

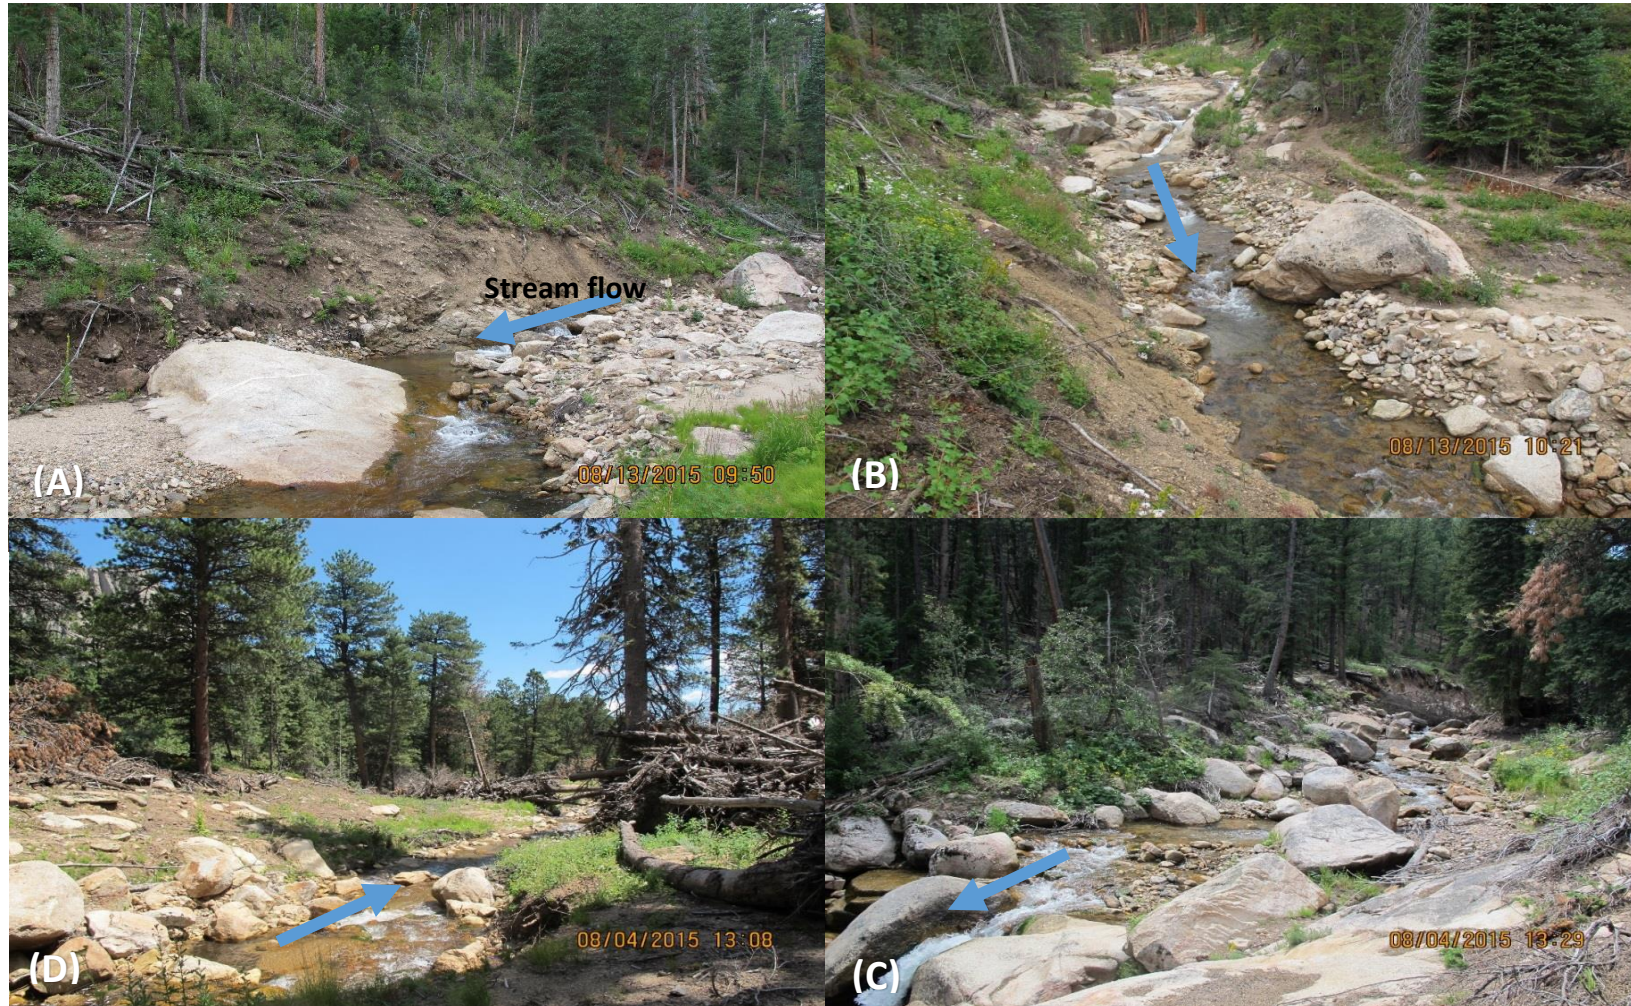
Figure 5. Scour images for Black Canyon Creek taken August 2015. Examples of the types of effects on BCC from the flood and debris flow. A) Bank erosion and boulder bar deposition 280 meters downstream of Reach 1. B) An example of incision to bedrock (above blue arrow) and bank erosion 280 meters downstream of Reach 1. C) Riparian vegetation removed by the flood on the left bank and accumulation of LW on the right bank between Reach 2 and Reach 3. D) Deposition of large boulders and channel widening in Reach 4.

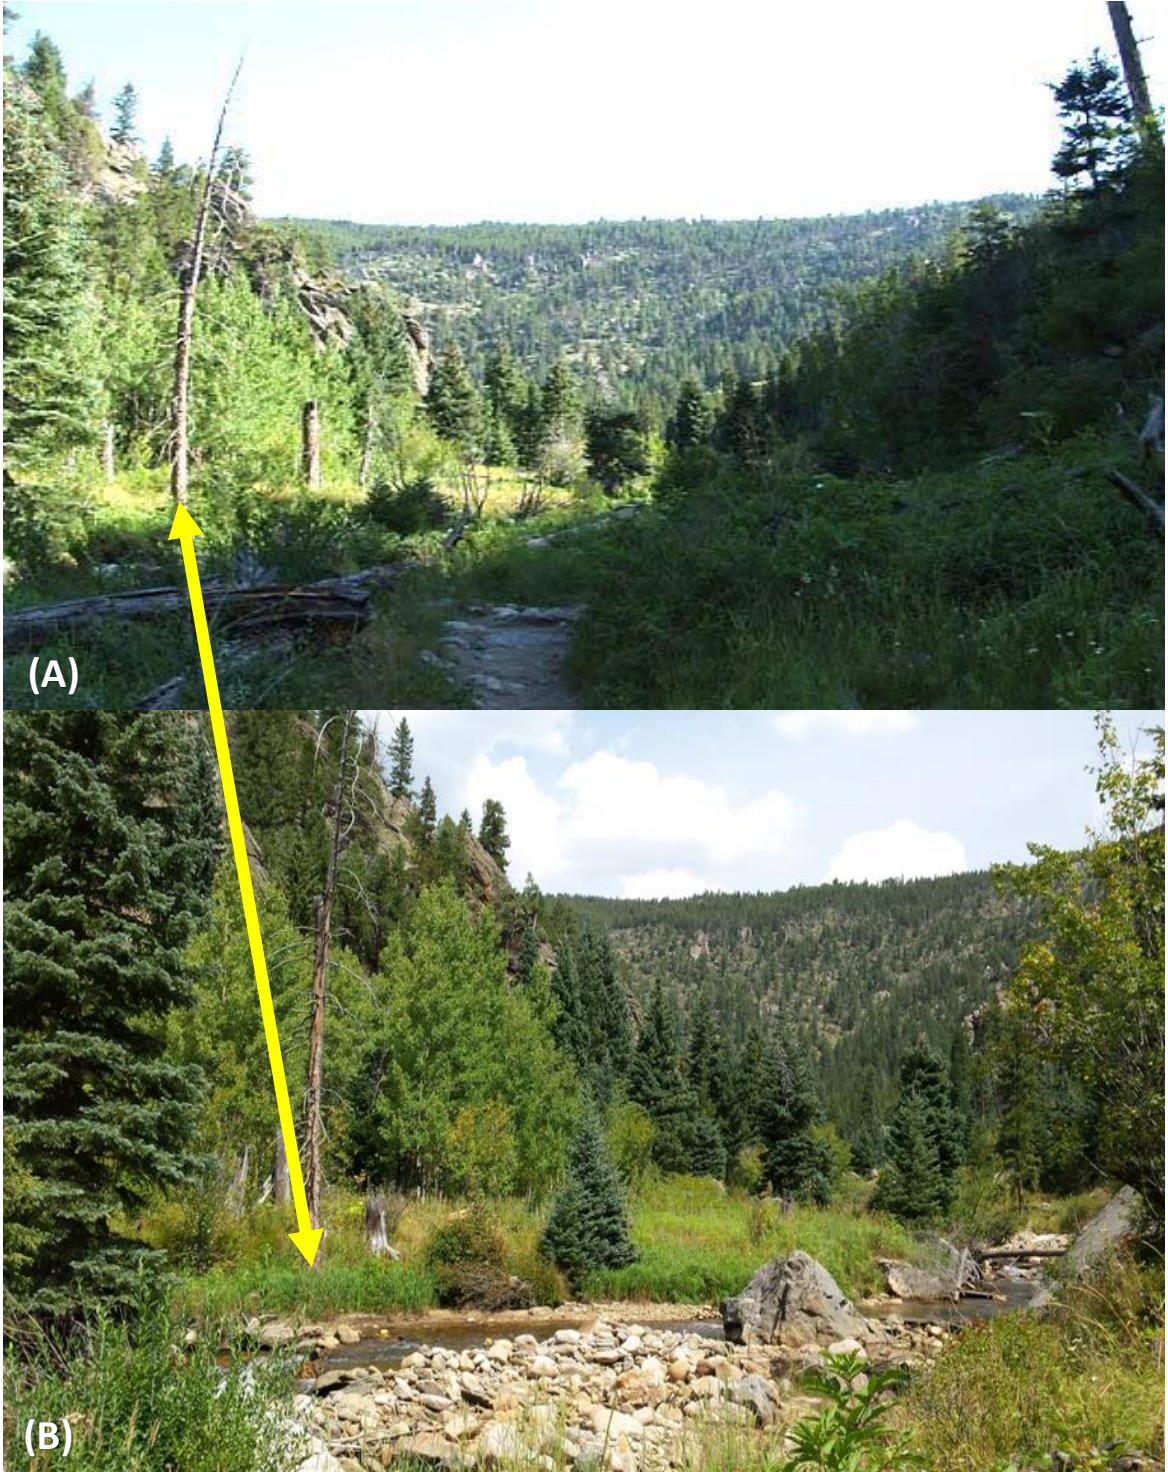
channel response here (Ryan, 2015). Landsliding is not prevalent on the 2011 Google Earth imagery along this reach, but there are noticeable bank failures from channel widening and loss of riparian forest along the lower portion (Figure 6).

Figure 6. Before and after flood image at North Fork Big Thompson. An example along NFBT, between Reach 2 and 3, of channel widening and erosion of streamside vegetation. Yellow arrow highlighting the base of a tree used as a reference point. A) Before the flood in 2012 (<http://hikingcoloradotrails.com/trails/north-fork-trail.php>). B) Photo taken during my internship in August 2015.

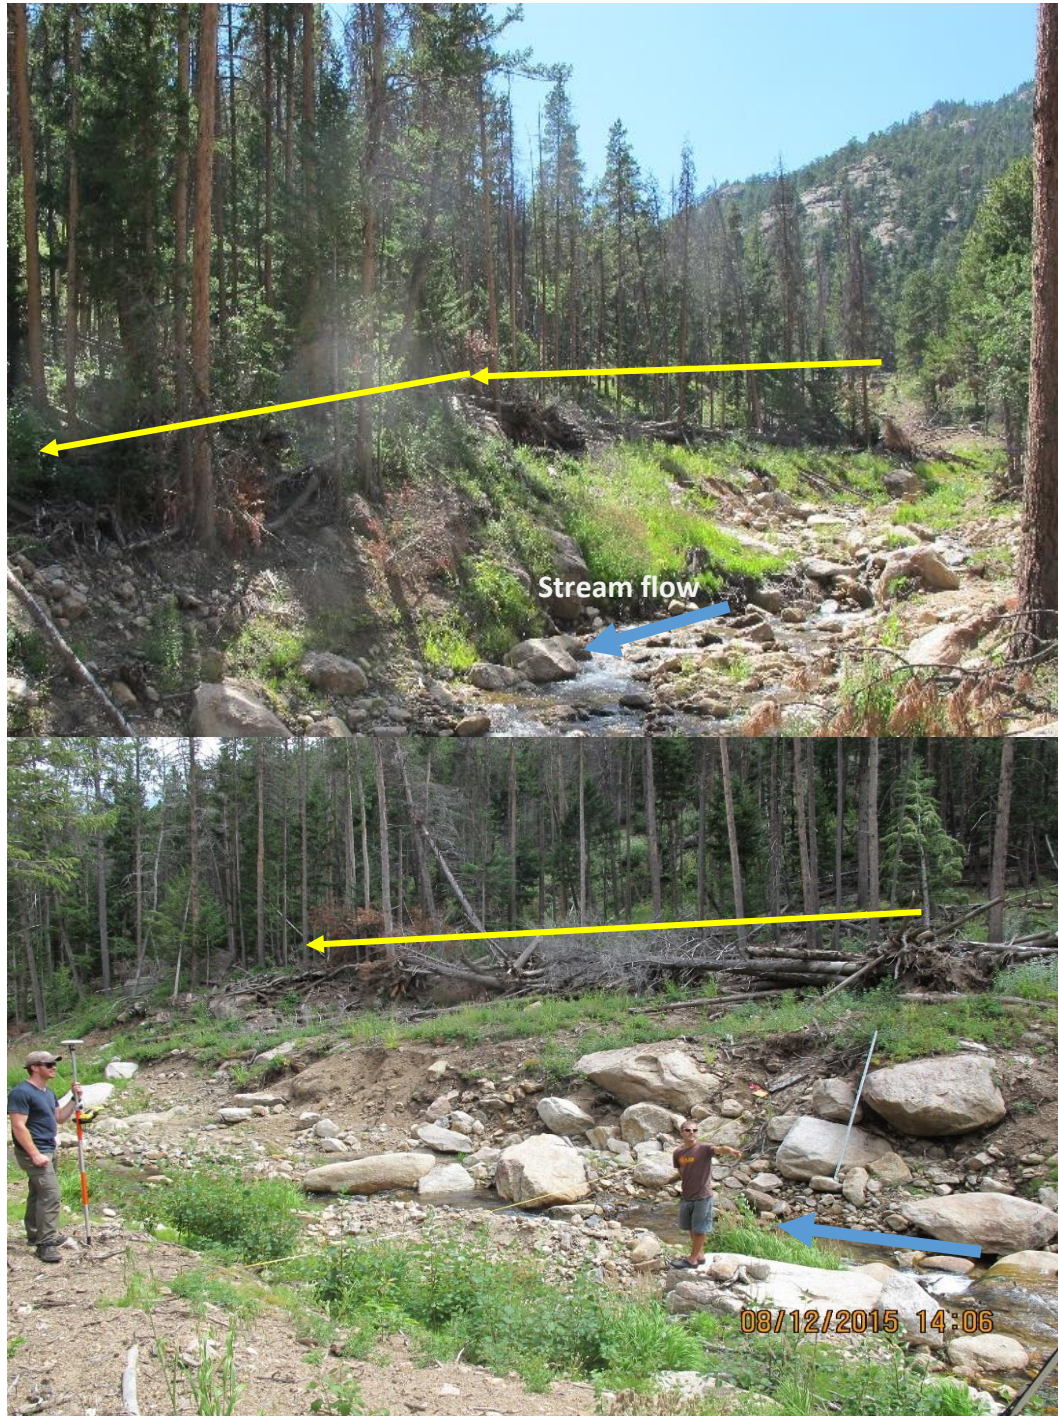
Much of the deposited wood in BCC collected as one elongated mass of debris parallel to the stream, referred to here, as a debris line, and is seen throughout the upper half of the study area (Figure 11). Because I did not consider debris lines to be jams, I did not include them in my data collection.

Figure 11. Debris line example in Black Canyon Creek along the right bank. Yellow arrow highlights elongated pattern of LW deposition that is parallel to the stream flow. Photo taken from left bank at Reach 1.

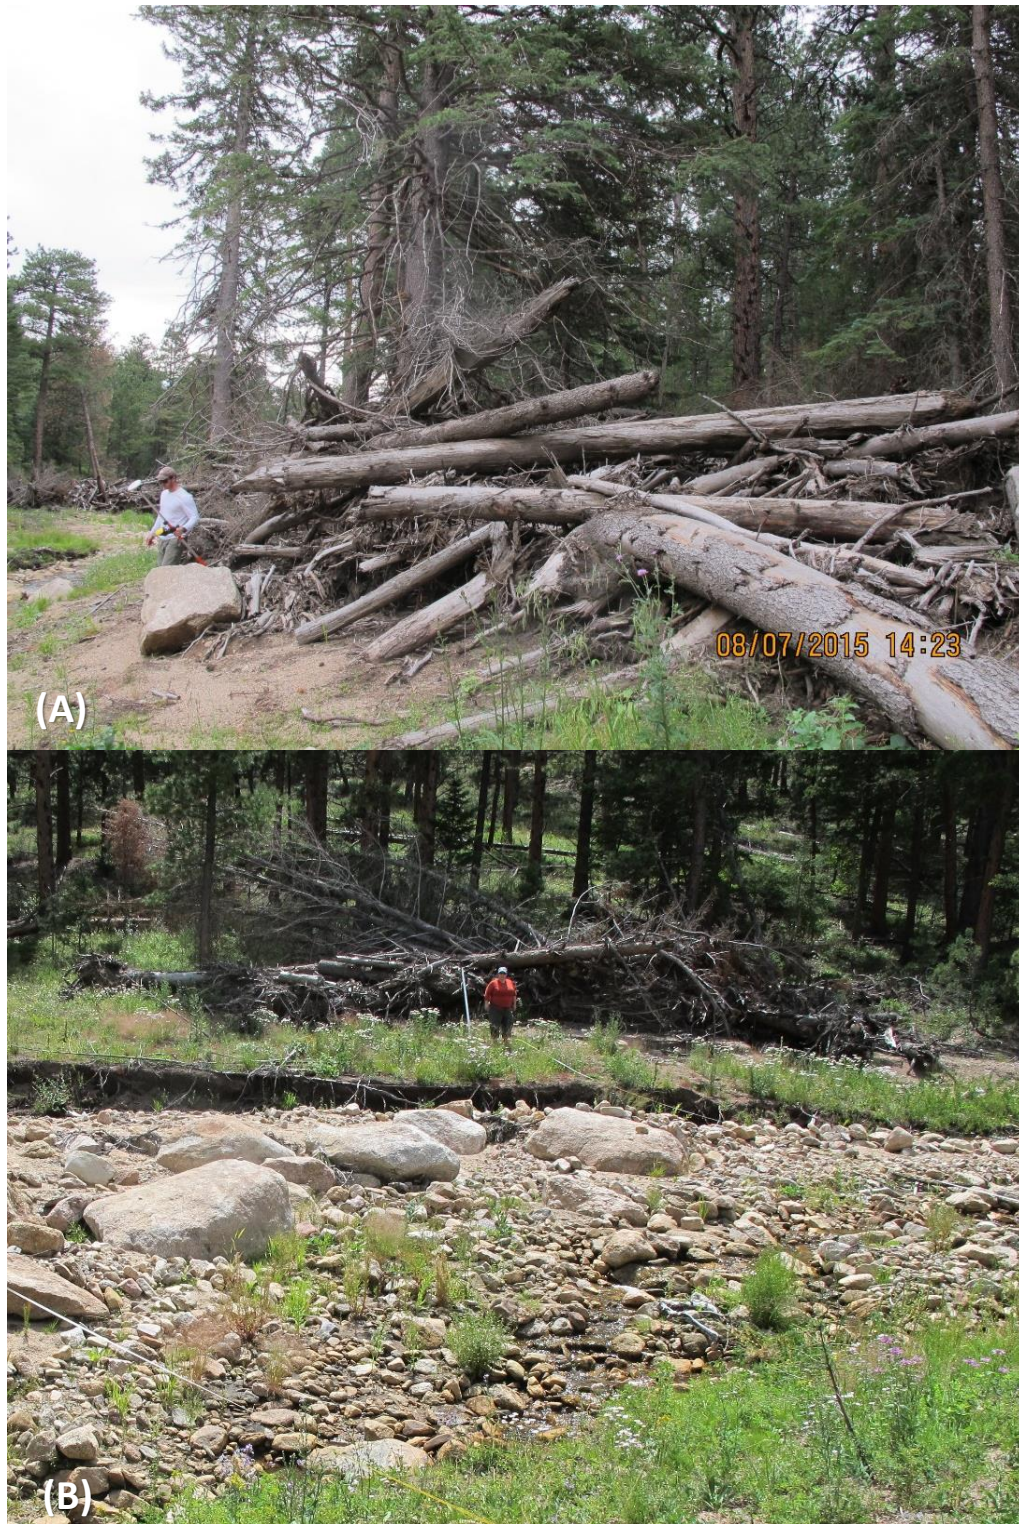
Figure 13. Large wood jams along Black Canyon Creek. Photos show a range of extent in the accumulation behind stable, upright trees. A) A LW jam in Reach 4. 5) A LW jam in Reach 5.

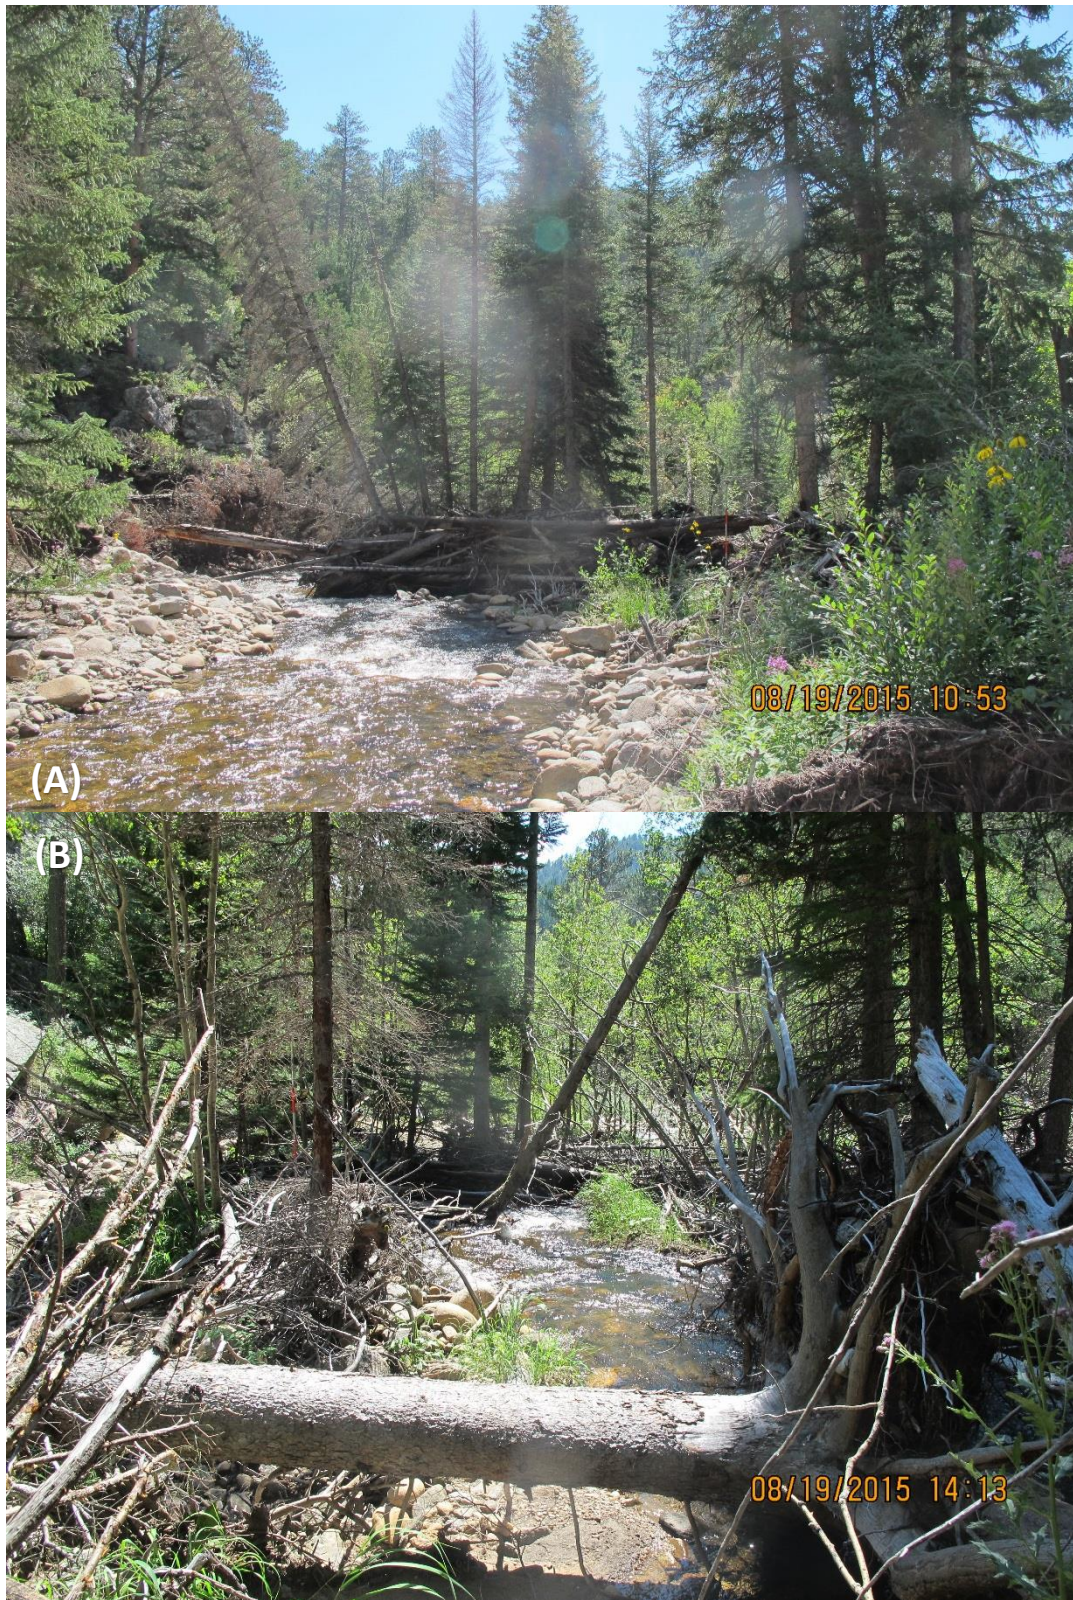
Figure 14. Large wood jams along North Fork Big Thompson. Photos show a range of extent in the accumulation behind stable, upright trees along and in the stream. A) A LW jam in upstream of Reach 4. B) A LW jam in Reach 5.
