THE ROLE OF LARGE WOODY DEBRIS AND RIPARIAN FOREST IN CHANNEL AVULSION IN THE CARBON RIVER, MOUNT RAINIER NATIONAL PARK, WA

Master of science
Earth and Space Sciences: Applied Geosciences

University of Washington
May, 2016

MESSAGE Technical Report Number: 037

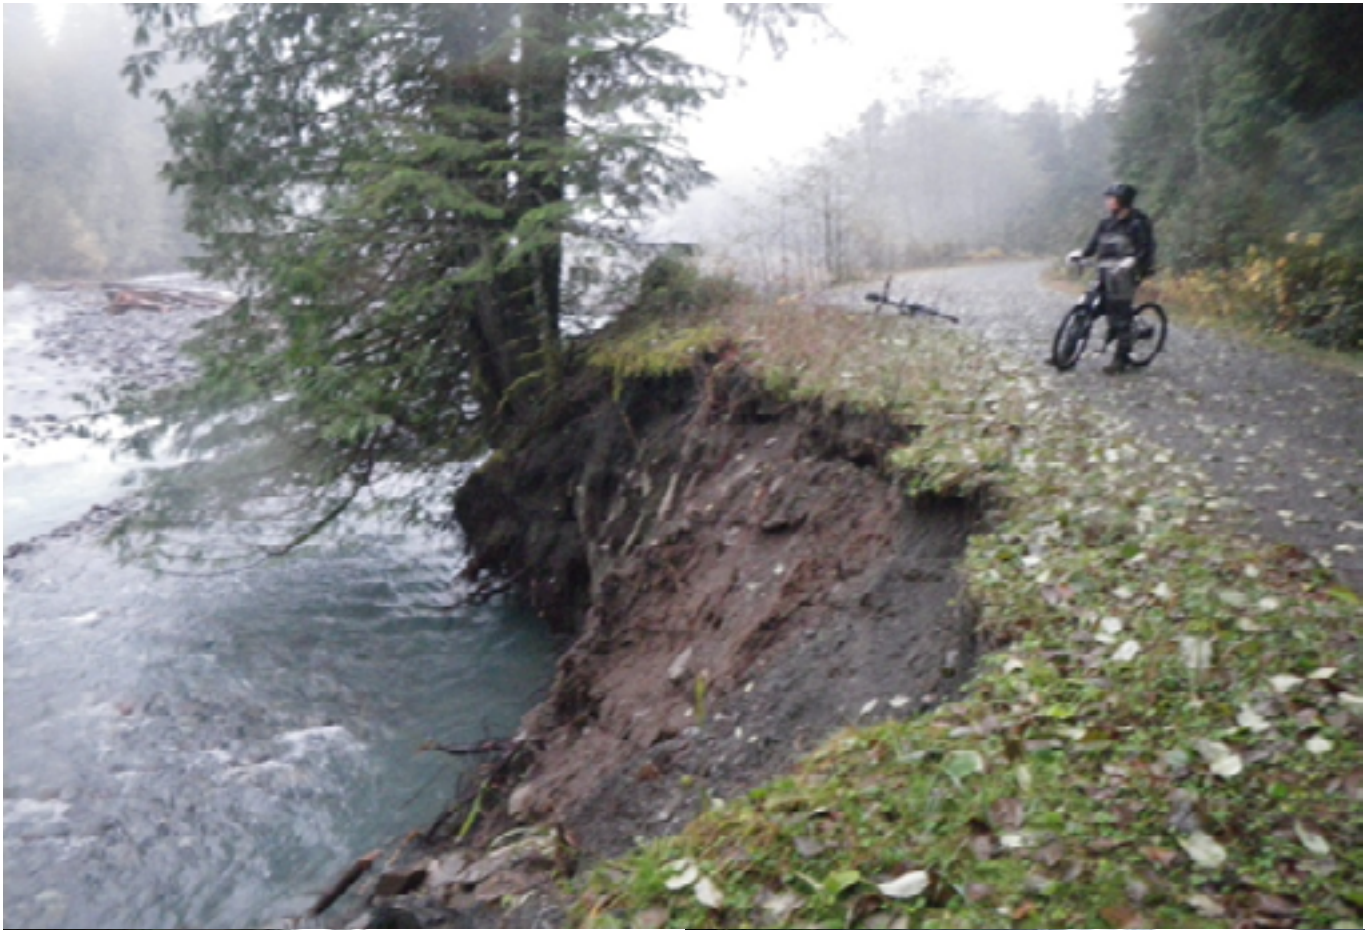
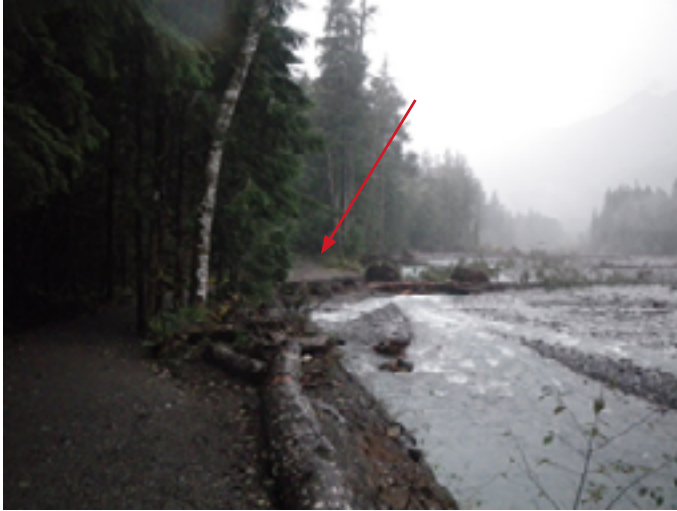
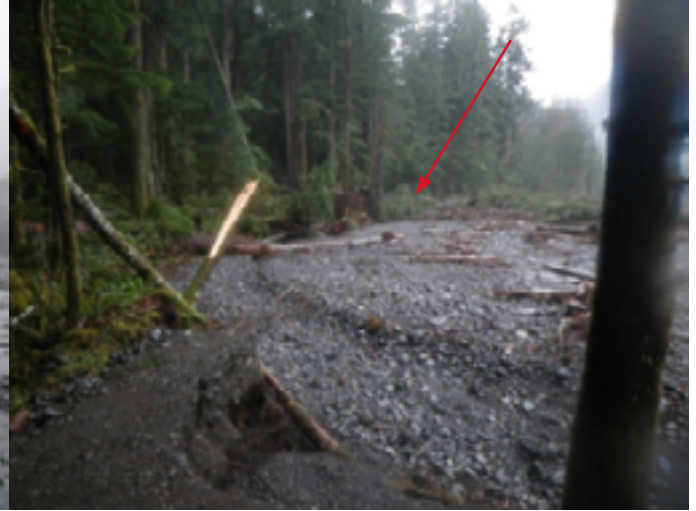
Figure 3: Flood damage from the 2015 winter storm event. This is located at 8.5 river-kilometer, which is just downstream of Chenuis Falls. Red arrow in the lower figures show same location before (bottom left) and after (bottom right) the flood event. Photographs obtained from Paul Kennard (2015).

At river-kilometer 9.3, there is another low-lying floodplain (Figure 28). RWSE map shows several secondary channels that flows into Ranger Creek before returning back to the Carbon River main channel. This section of the river saw several proposed flood control measures by GEOMAX in 2008, including bank barbs, cross-valley dike, flood dike, and road humps. Due to the proximity of the main channel to the Carbon River Road and valley wall, erosional hazards have caused significant damages since 2006. In 2015, the Carbon River continues to erode the road away (Figure 3).

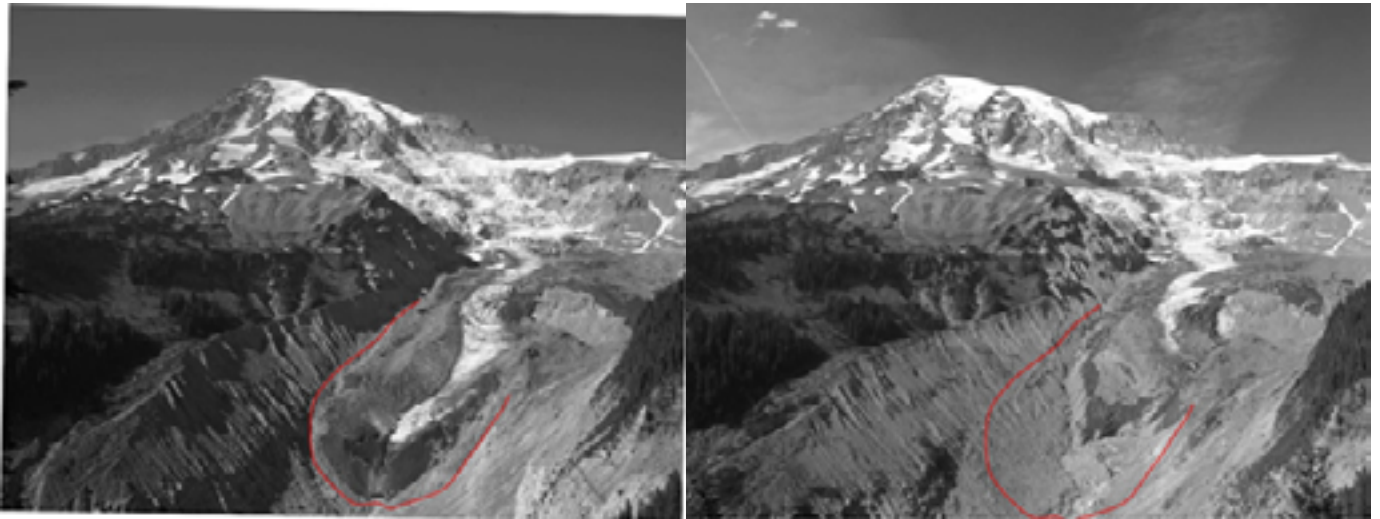
Figure 4: Nisqually glacial retreat from 1974 to 2004. Red line indicates same position of the 1974 extent of glacier. Photographs obtained from Paul Kennard.

Glacial recession affects sediment inputs into river valleys and can have significant implications to geologic hazards in Mount Rainier National Park (Beason et al., 2014). Mountain-wide glacier volume loss has been estimated at 14% from 1970 to 2008 (Sisson et al., 2011). Although no publication was found for the recession of the Carbon Glacier, Reidel et al. (2015) has been monitoring two of the major glaciers from 2003 to 2011—Emmons (11.6 square-kilometer) and Nisqually (6.9 square-kilometer). Cumulative net volume loss in the eight years is 89.4 million cubic-meter for Emmons Glacier and 58.1 million cubic-meter for Nisqually Glacier (Figure 4). Similar volume recession is expected for the Carbon Glacier.

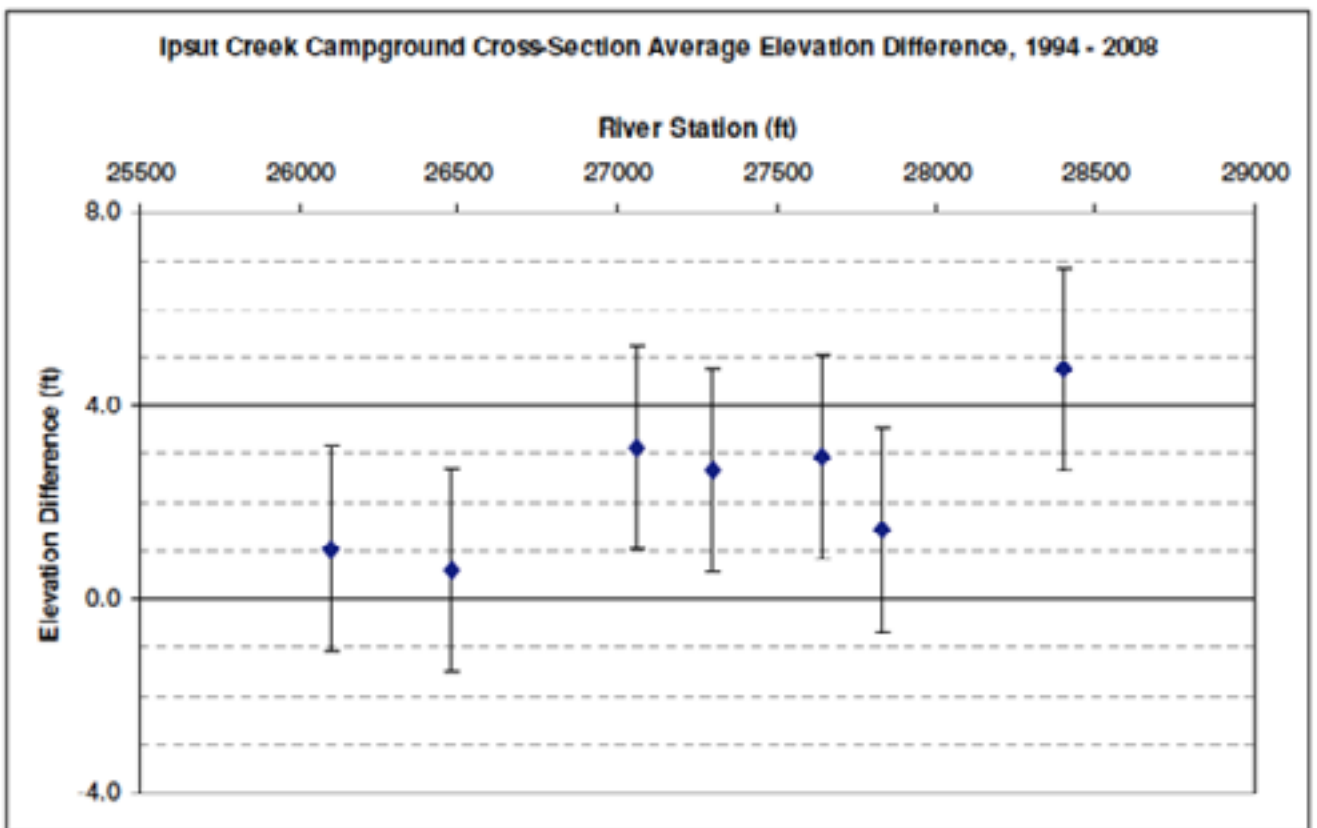
Figure 5: Estimated elevation difference between 1994 and 2008 at Ipsut Creek campground cross sections. The Carbon River flows from figure-right to figure-left (Entrix, 2008).

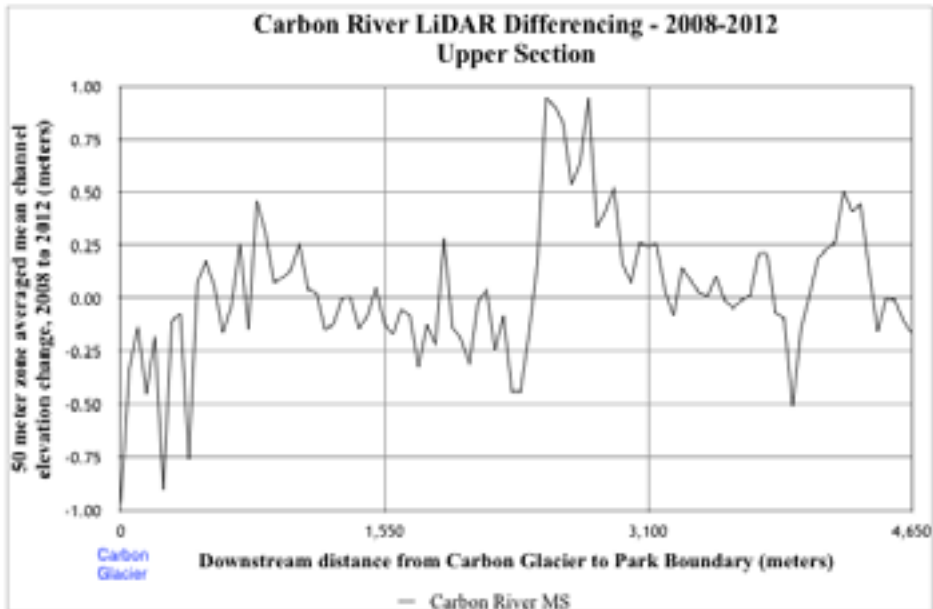
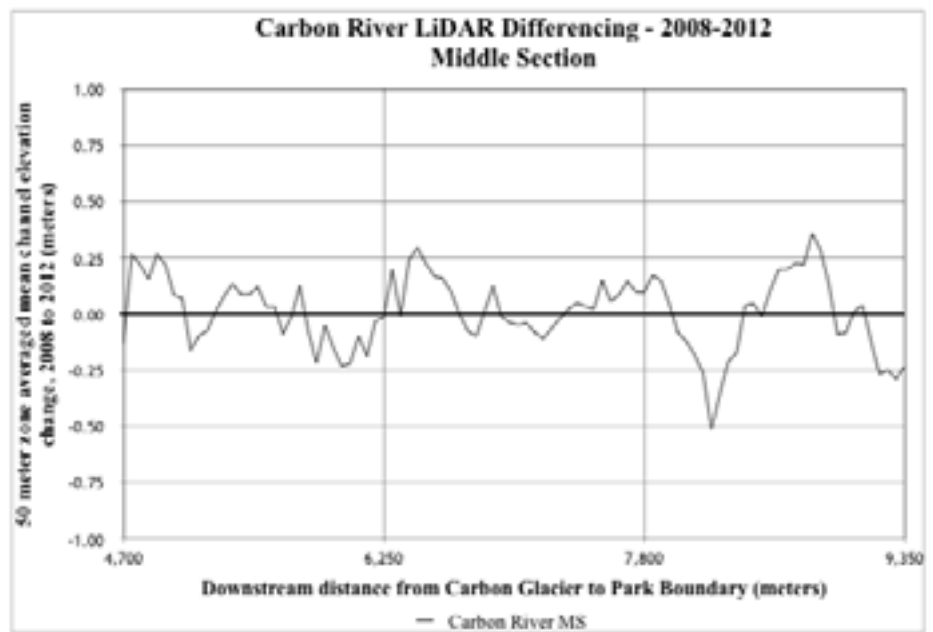
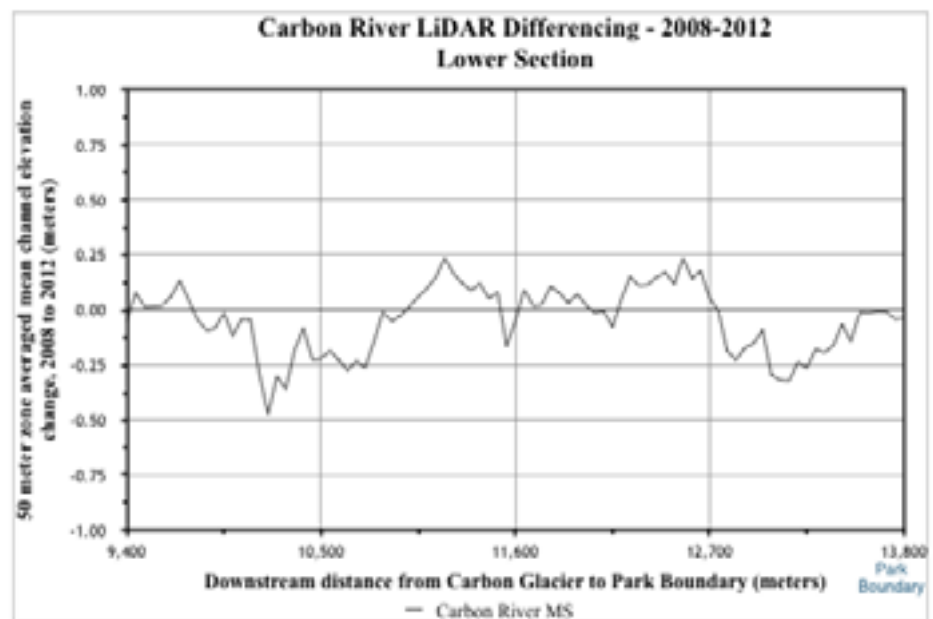
Figure 6: Results from DEM differencing from 2012 and 2008 LiDAR for three sections of the Carbon River within the Park boundary (Knoth, 2013).

recurrence interval). In a similar study, Knoth observed aggradational trend in the Carbon River between the Carbon Glacier and Mother Mountain between 2008 and 2012 through LiDAR DEM differencing (Figure 6). Highest aggradation rate of 0.25 meters/year was seen between river-kilometer 2.5 and 3.0 (Figure 2, 6). Despite aggradation in the Carbon River close to the Carbon Glacier, Knoth (2013) observed no significant bed elevation change in the Ipsut Creek Campground vicinity, and even incisional trends close to the Park entrance (Figure 6).

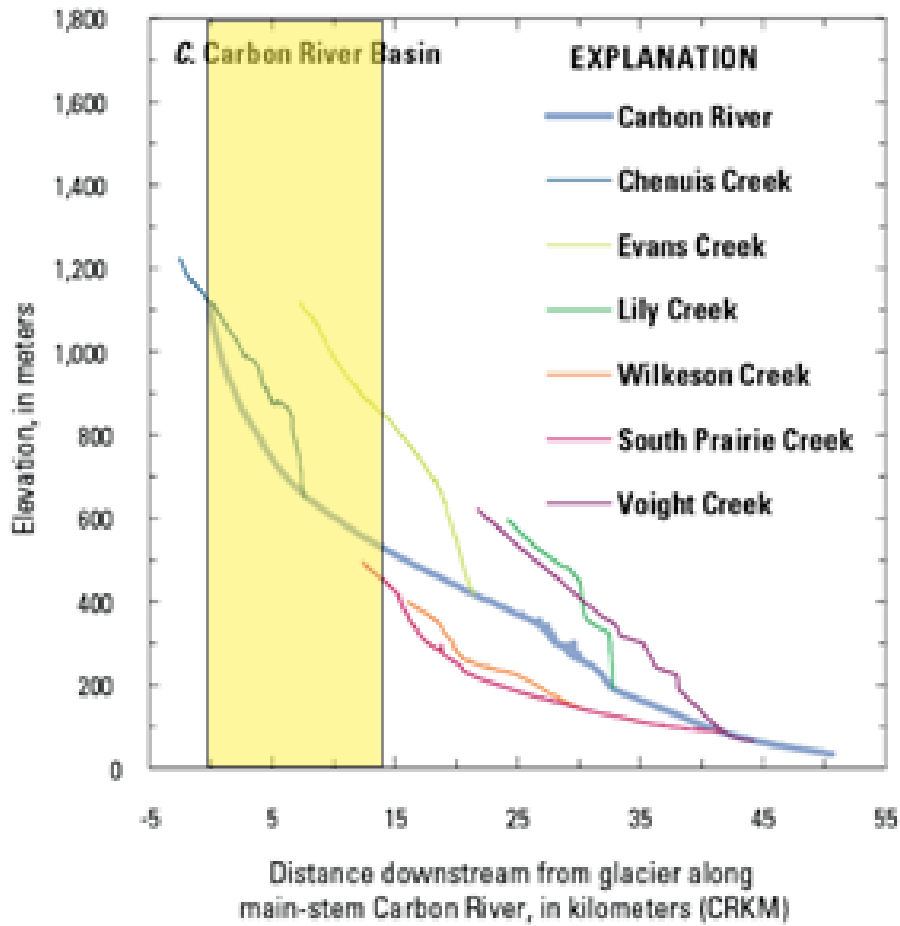
Figure 7: Longitudinal profile of various rivers that radially drains Mount Rainier. Yellow shaded area indicate studied reach (modified from Czuba et al, 2012).

The study reach is characterized by a braided stream with a concave longitudinal profile (Figure 7) (Czuba et al., 2012). Slope in the headwaters decrease from 0.1 to 0.06 near the Carbon Glacier and gradually decreases from 0.02 near Mother Mountain to 0.015 at the park entrance; channel width typically ranges from 150 to 300 meters. One-quarter of the bed material within 3 kilometers of the glacier terminus consists of boulders. Grain size distribution generally decreases downstream, becoming predominantly cobbles with 10-20% of sand in the bed material. (Czuba et al., 2012).

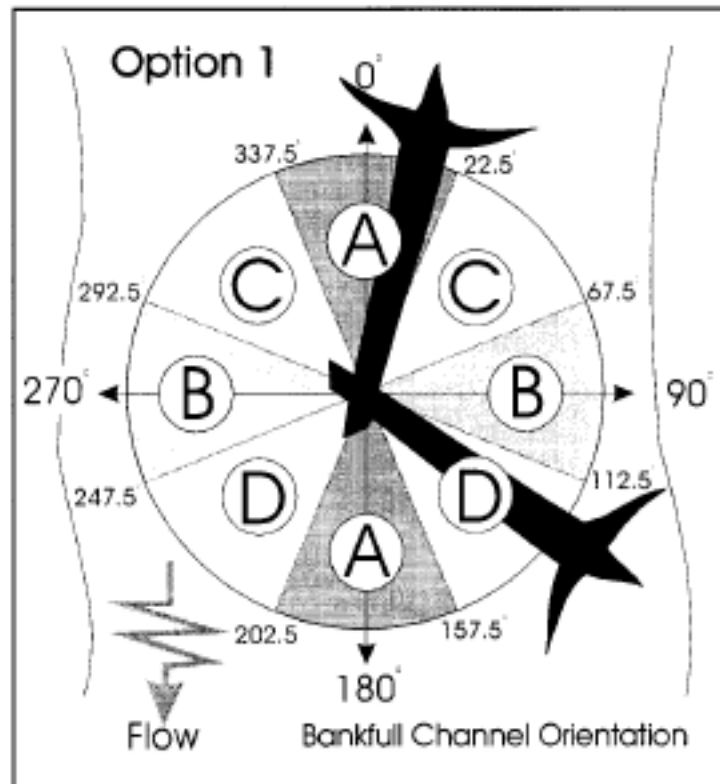
Figure 8: Orientation of log placement relative to flow (based on Bilby and Ward, 1991).

Woody debris accumulation orientation: measurement to indicate orientation of log placement relative to flow. This is categorized into quadrants based on wood survey method by Bilby and Ward (1991). Figure 8 shows whether the log jam can be parallel (A), perpendicular (B), or askew (C and D) to the current flow direction of the main channel.

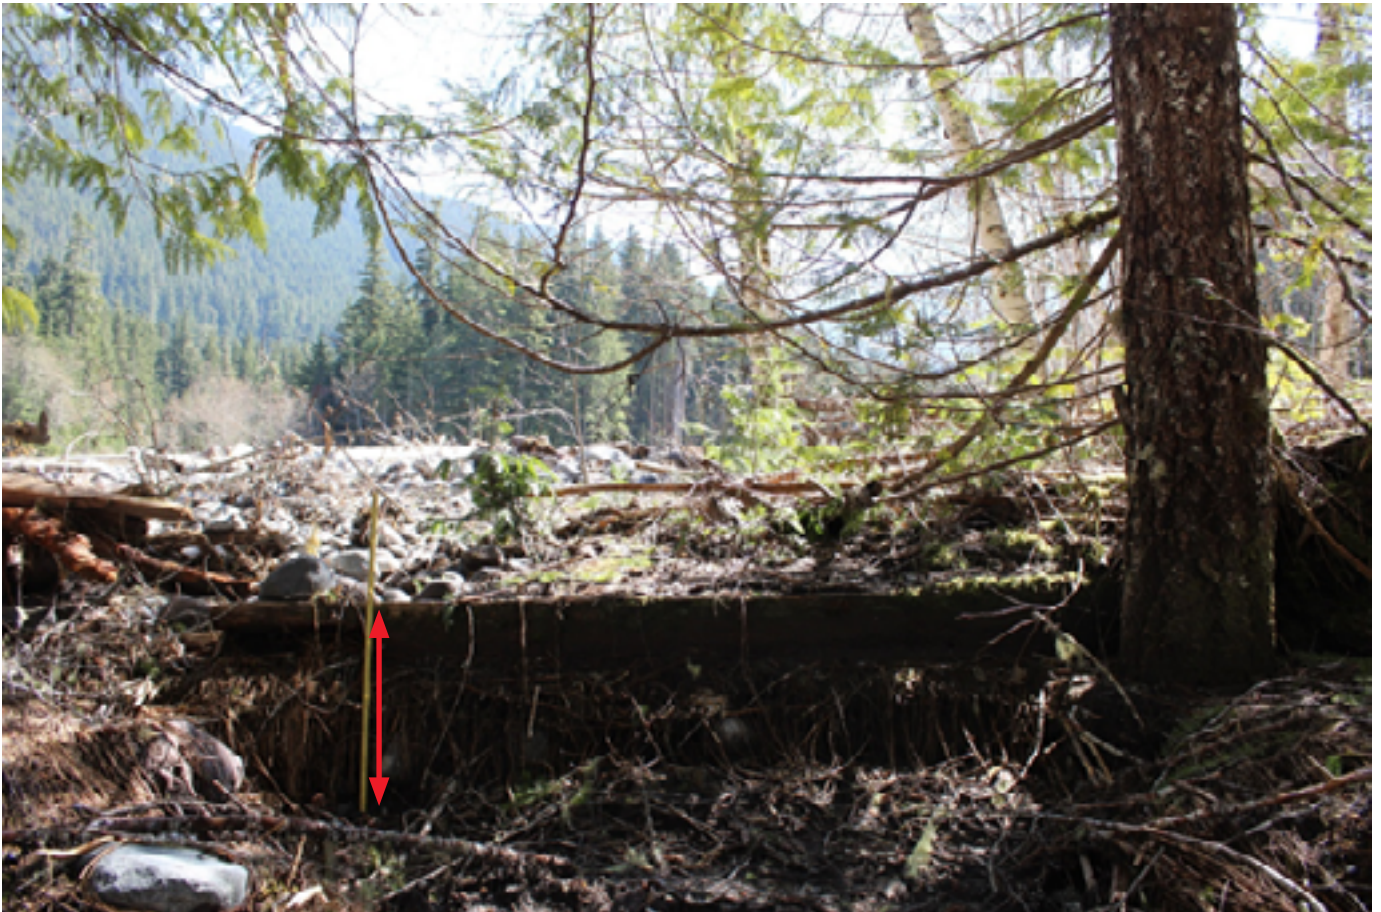
Figure 9: Double arrow line show the bed-surface elevation change at a fence jam.

Bed-surface elevation change: measurement of the vertical drop from the locally aggraded bed-surface upstream to bed-surface downstream of the fence jam (Figure 9). A height difference was recorded at the point along the fence jam where bed-surface elevation change was at its maximum.

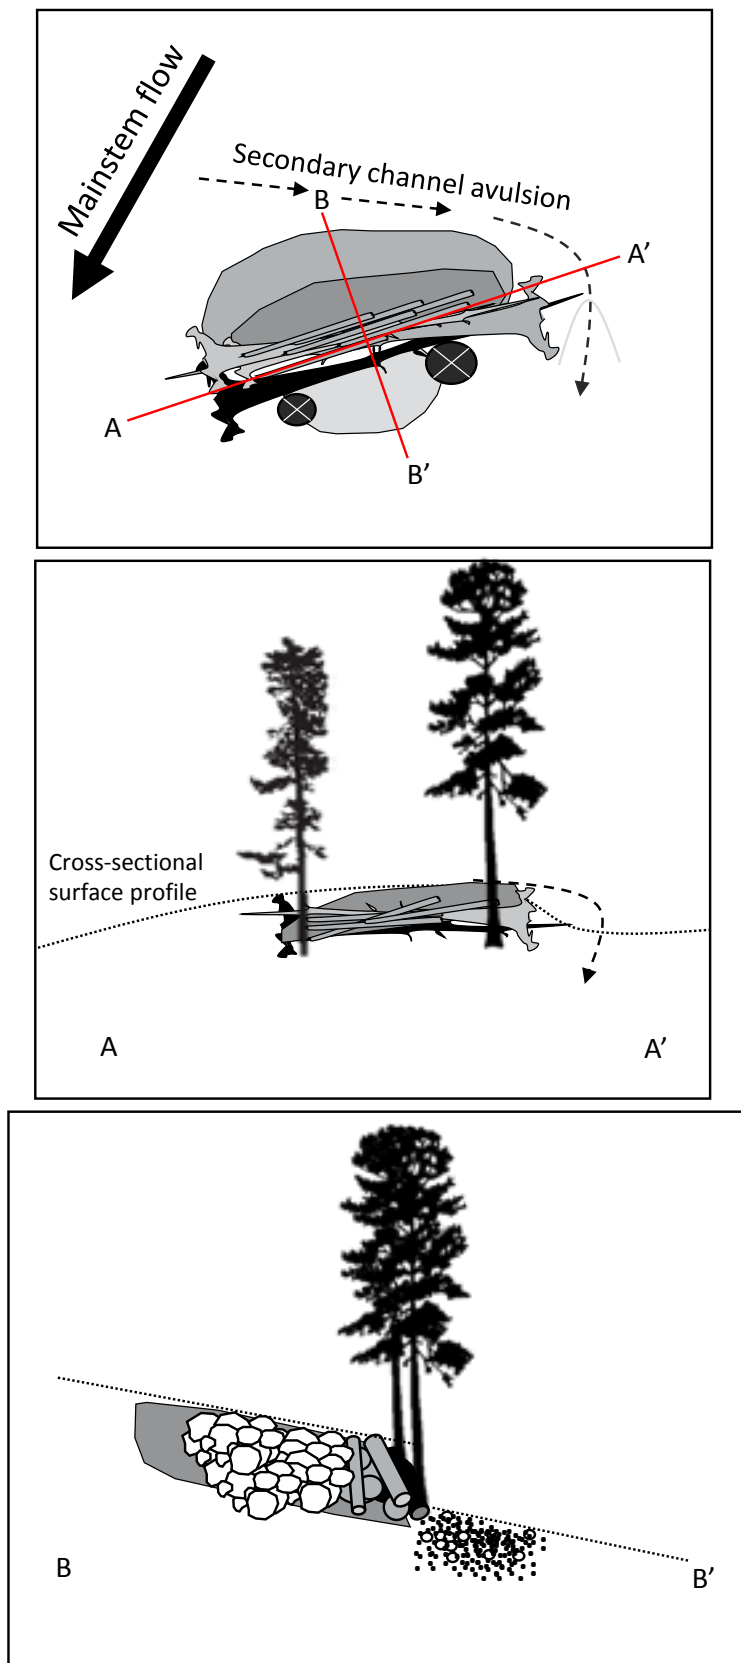
Figure 10: Schematic of an archetypal fence jam at various viewpoint: (a) Planview of fence jam showing standing riparian trees acting as “fence post” (black circle with x); keymember large WD acting as “fence rails” (black); additional stacked and loose WD (gray). Underlying shading shows coarse bed material (dark gray) to fine bed material (light gray). Arrow suggests avulsion pathways facilitated by the fence jam. Headcut is located directly to the right of the fence jam. (b) Upstream-view of a fence jam. (c) Cross-sectional view of a fence jam. Notice the bed-elevation change from upstream (figure-left) to downstream (figure-right).

A typical fence jam consists of fluvial-transported large woody debris as “fence rails” that are horizontally buttressed against standing trees or stump as “fence post” (Figure 10). Usually, a key rail member is identified to be the most stable that causes additional woody debris accumulation and sediment deposition, creating a steep vertical elevation drop from upstream channel bed to surrounding floodplain (Figure 11). Grain size generally ranges from cobbles to boulders upstream of the fence jam to coarse sand and cobbles downstream of the wood fence (Figure 12). The wood accumulation and subsequent sediment impoundment directly upstream of the fence jams effectively dissipate boundary shear stress by promoting spill resistance. Throughout the Carbon River, fence jams can occur at discrete locations where one or two standing trees can cause wood accumulation and sediment impoundment; it can also occur continuously where multiple fence jams are interconnected along the margins of the floodplain.

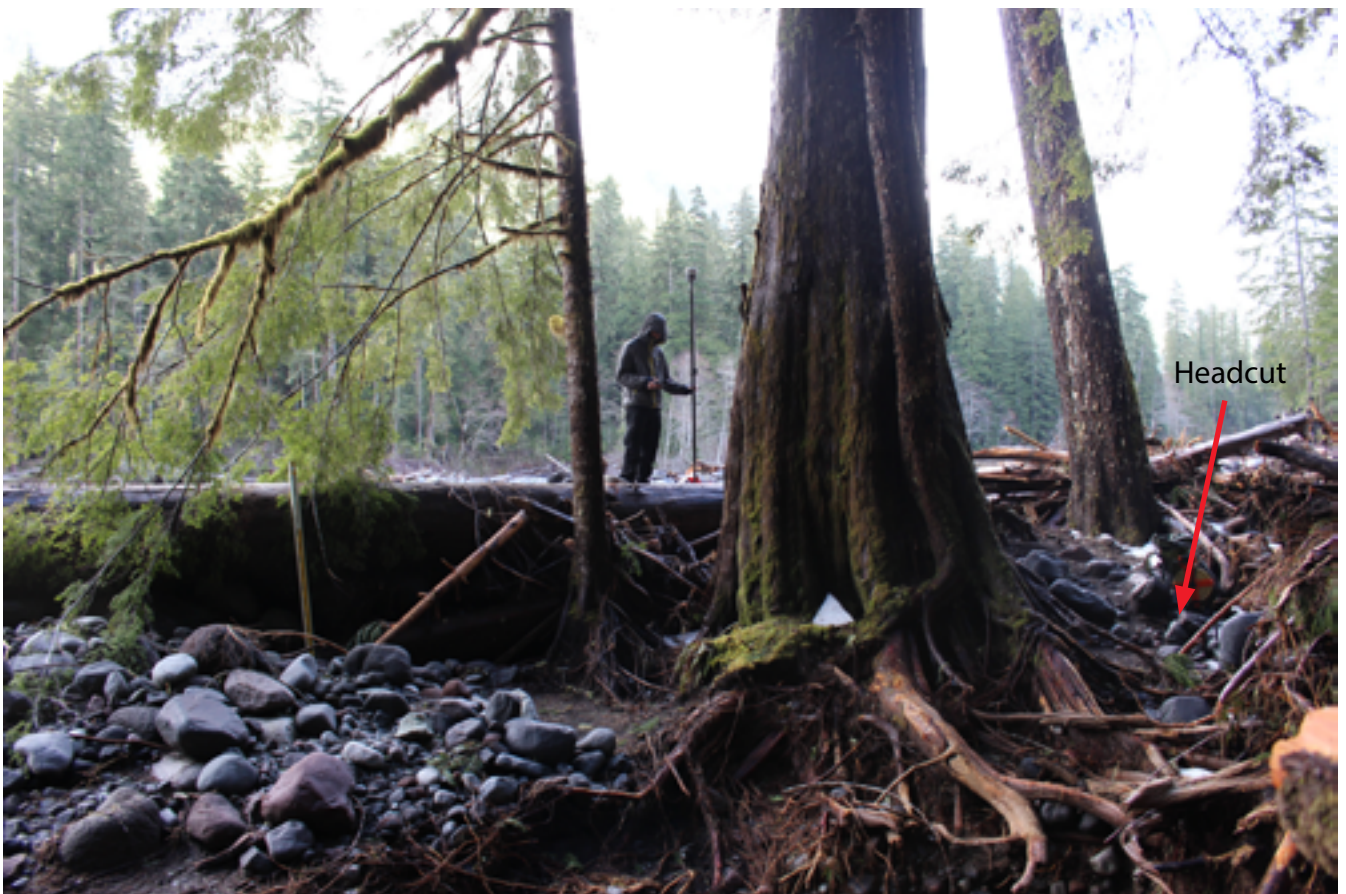
Figure 11: Picture of fence jam at WF-13 where a large WD is buttressed against two variously-sized standing trees. Mainstem of the Carbon is located behind PhD student, Jonathan Beyeler. Notice that Jon Beyeler is standing on top of the aggraded bed upstream of the fence jam, which is significantly higher than elevation downstream. Headcut is formed directly to the left of fence jam (figure-right).

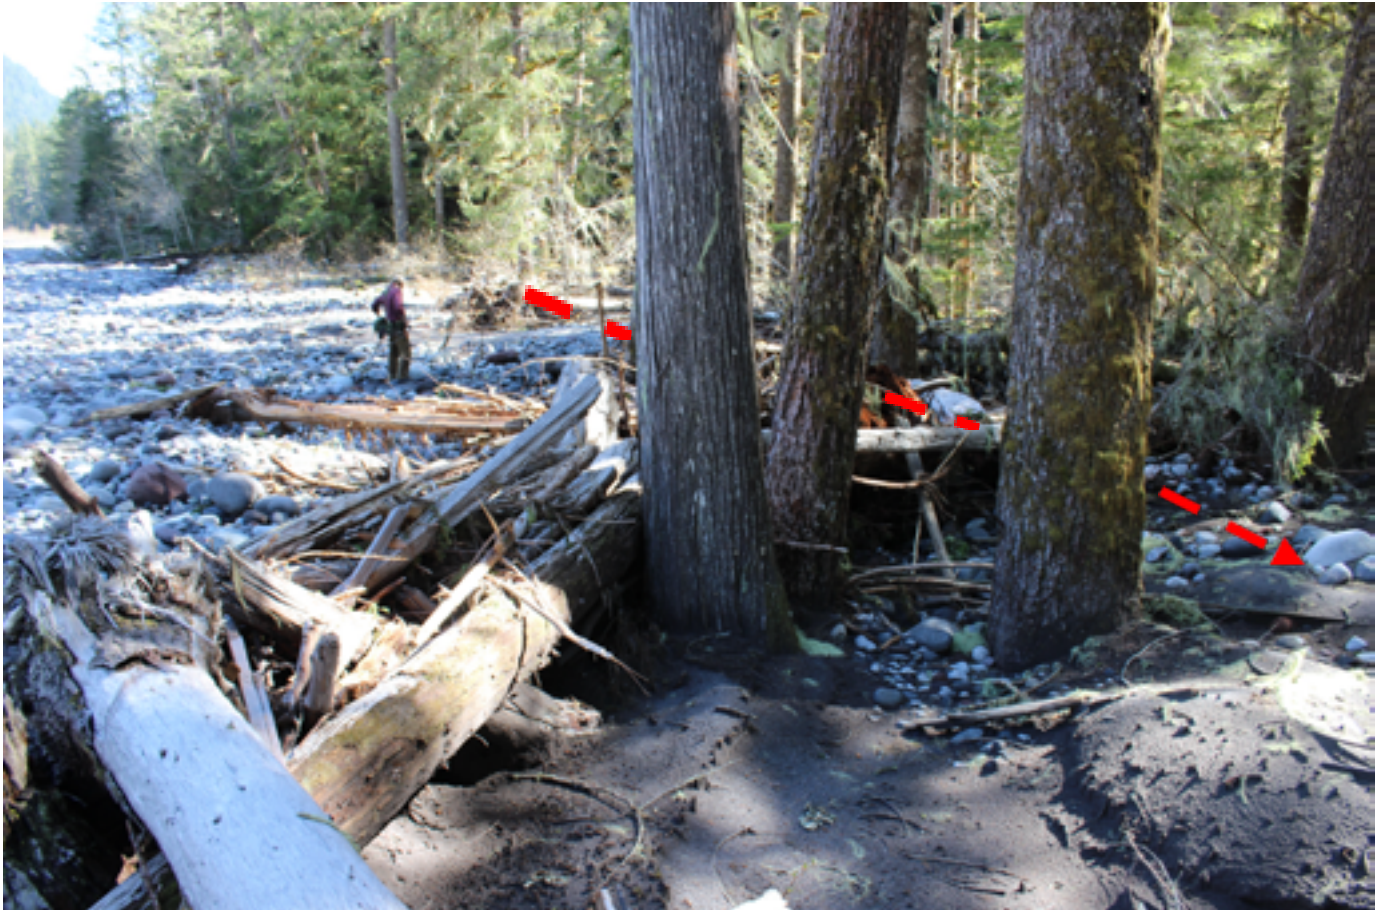
Figure 12: Picture of fence jam at WF-21 showing changes in bed material. Red dashed line shows avulsion pathway around the fence jam.

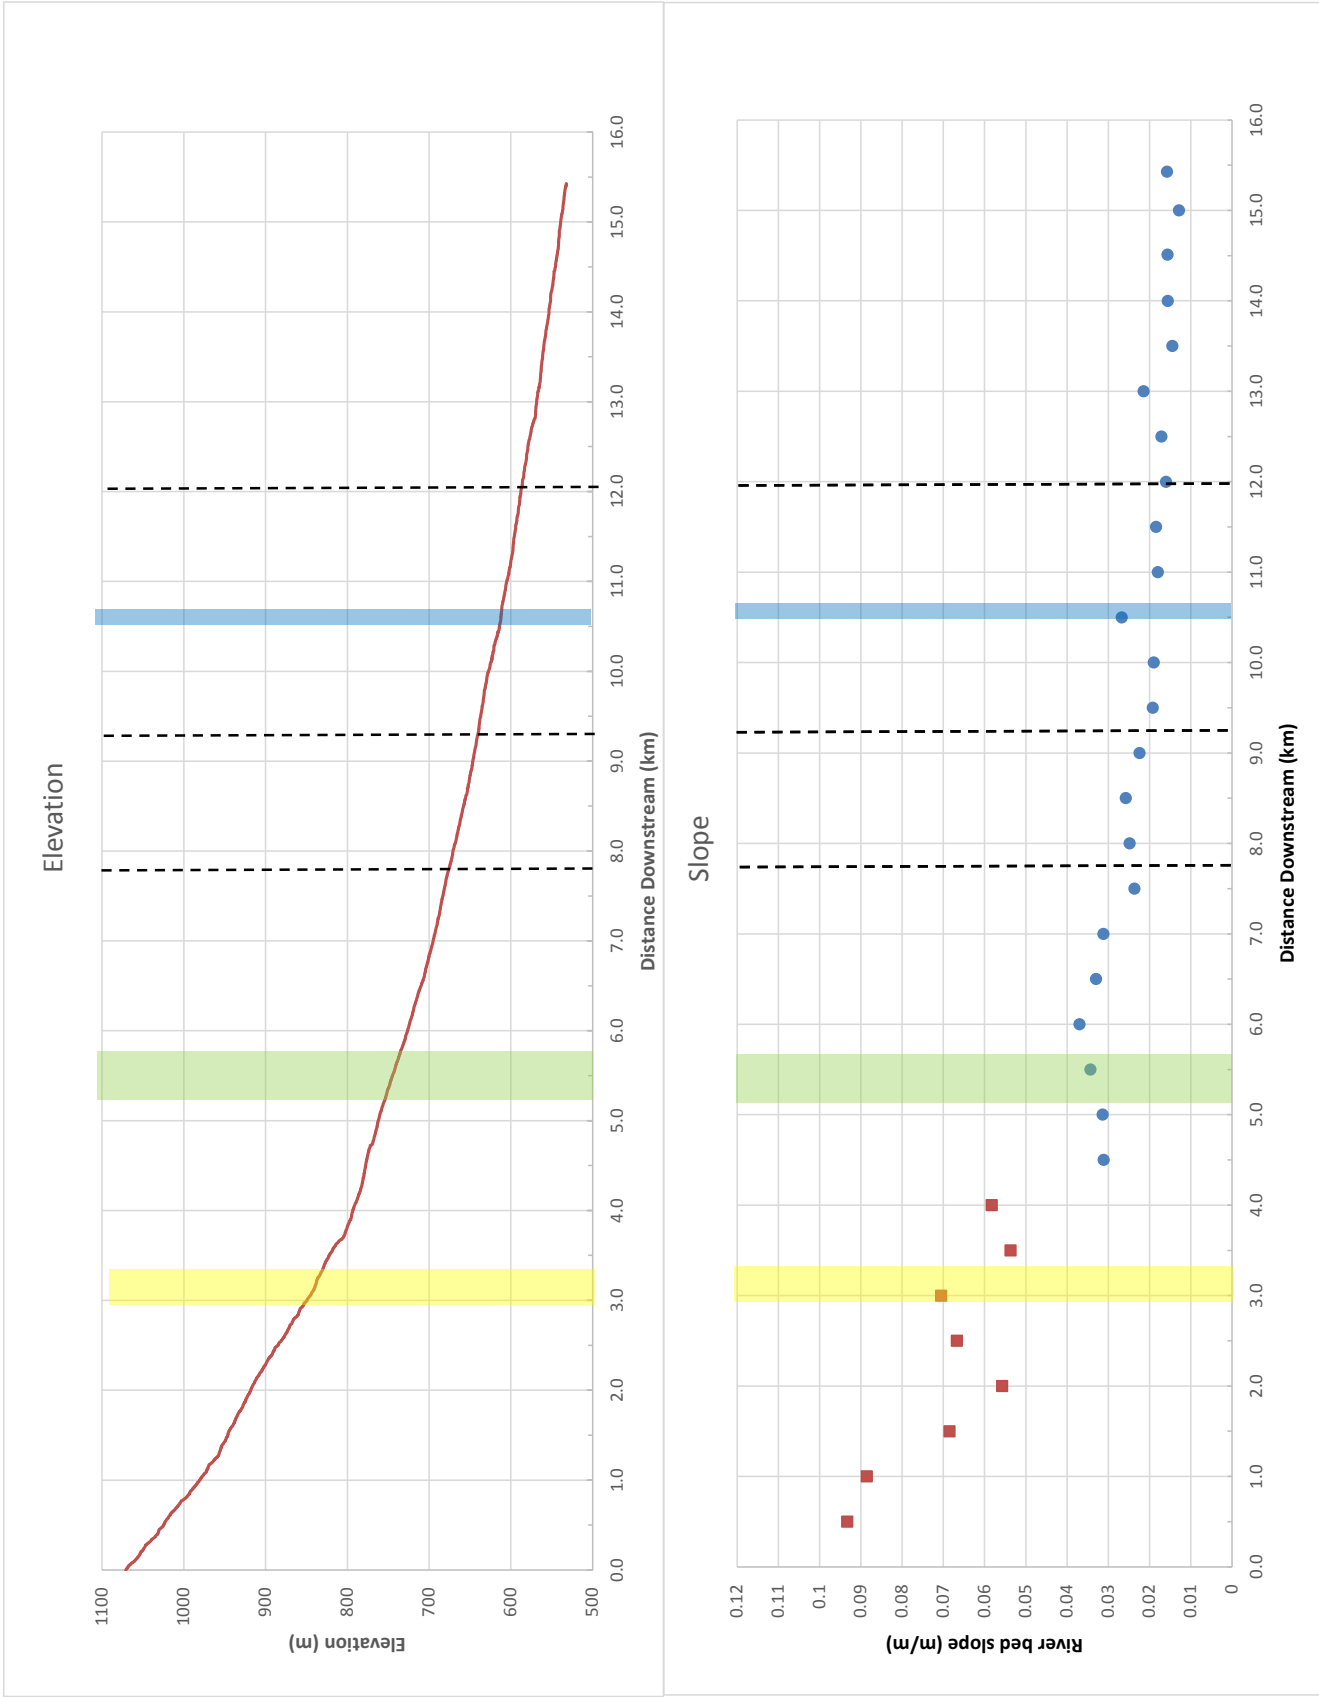
Figure 14: Longitudinal profile of the Carbon River from the Carbon glacier (figure-left) to the Park entrance (figure-right). Average slope is sampled at 500-meter intervals.

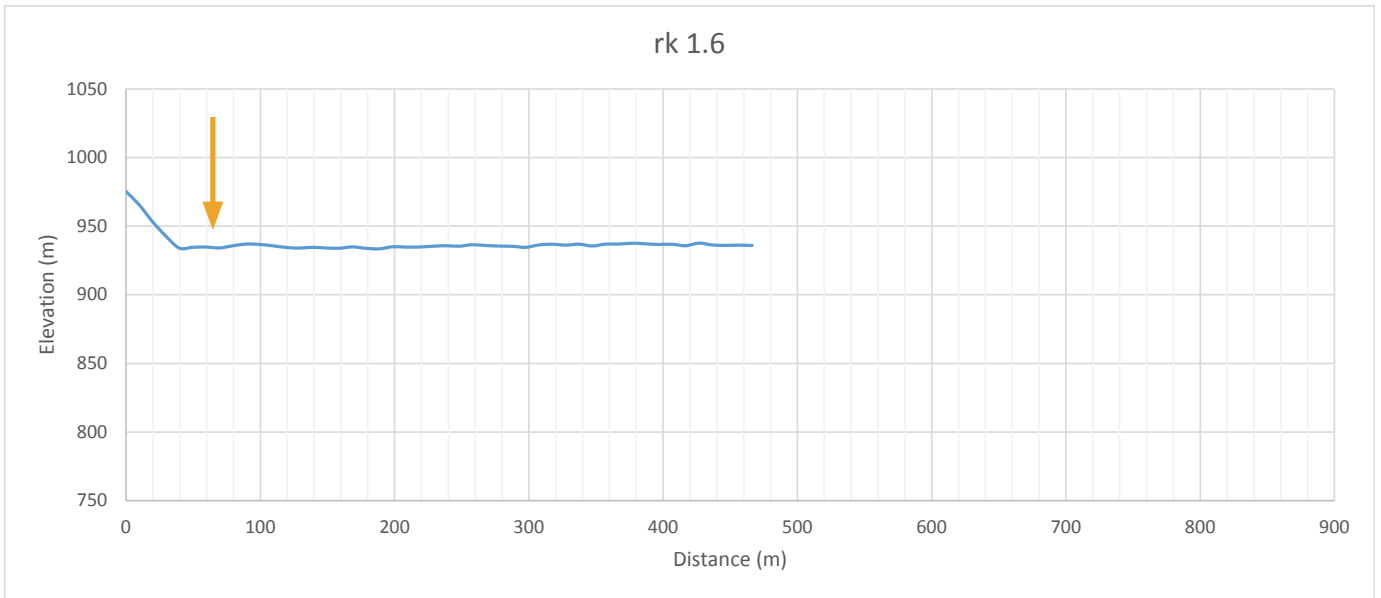
Figure 15: Cross-sectional profile sampled at river-kilometer 1.6. Orange arrow approximates position of thalweg.

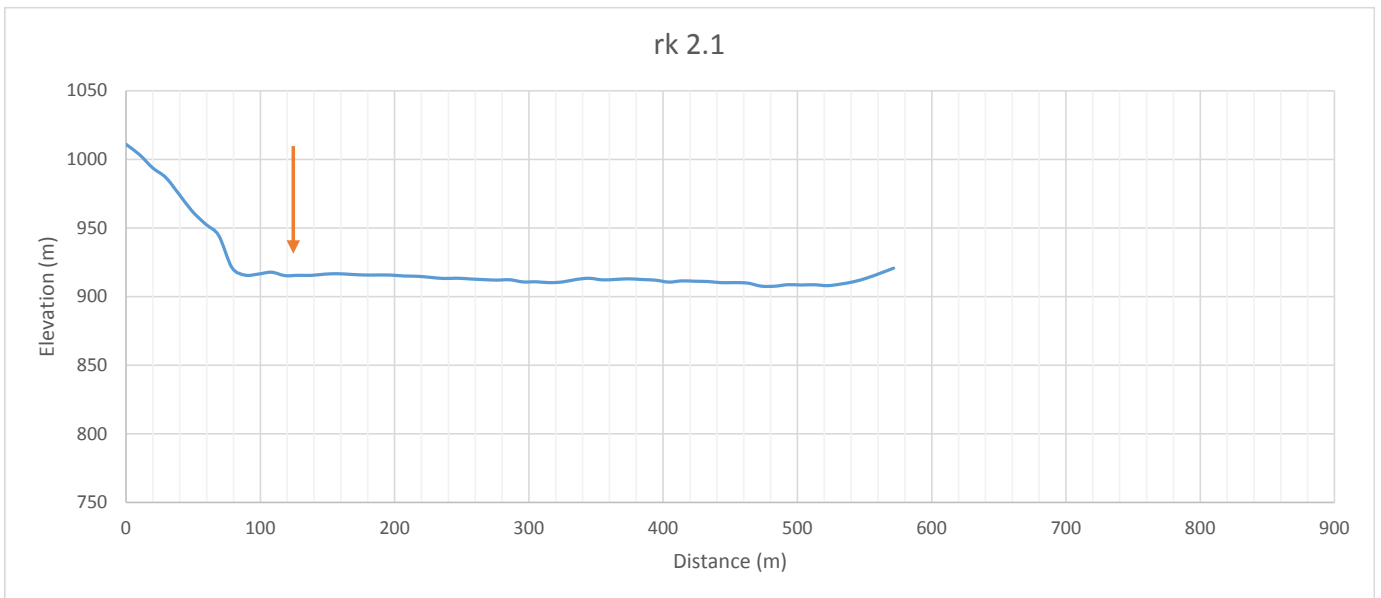
Figure 16: Cross-sectional profile sampled at river-kilometer 2.1. Orange arrow approximates position of thalweg.

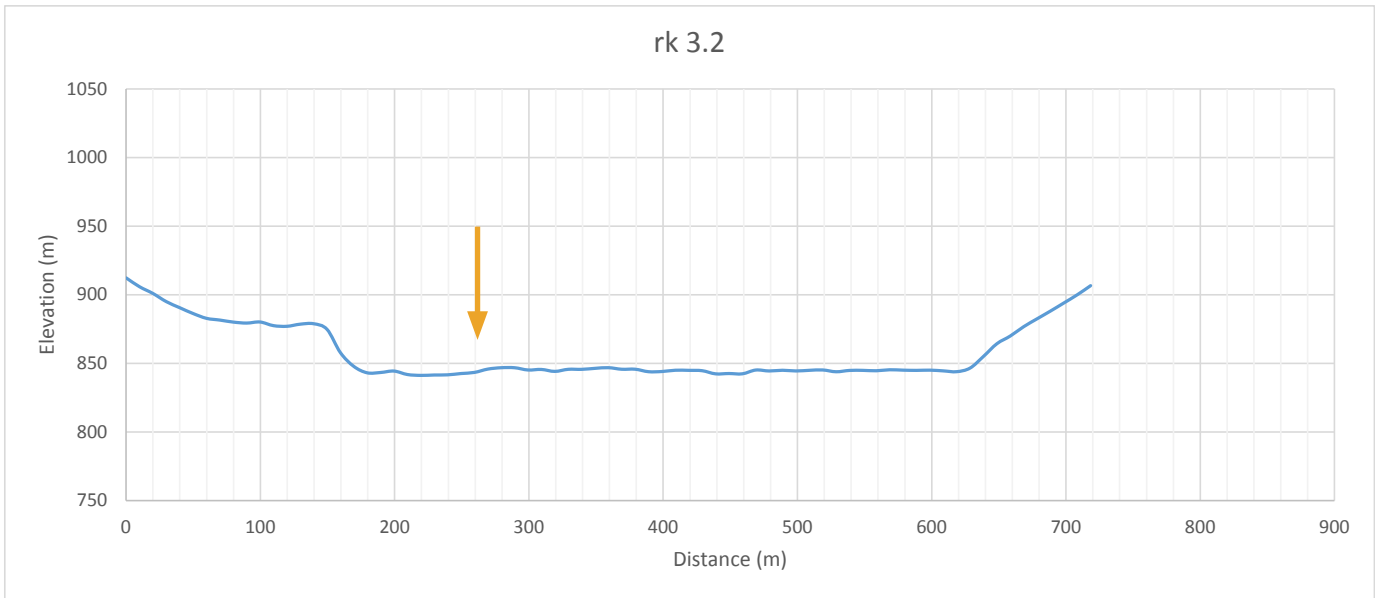
Figure 18: Cross-sectional profile sampled at river-kilometer 3.2. Orange arrow approximates position of thalweg.

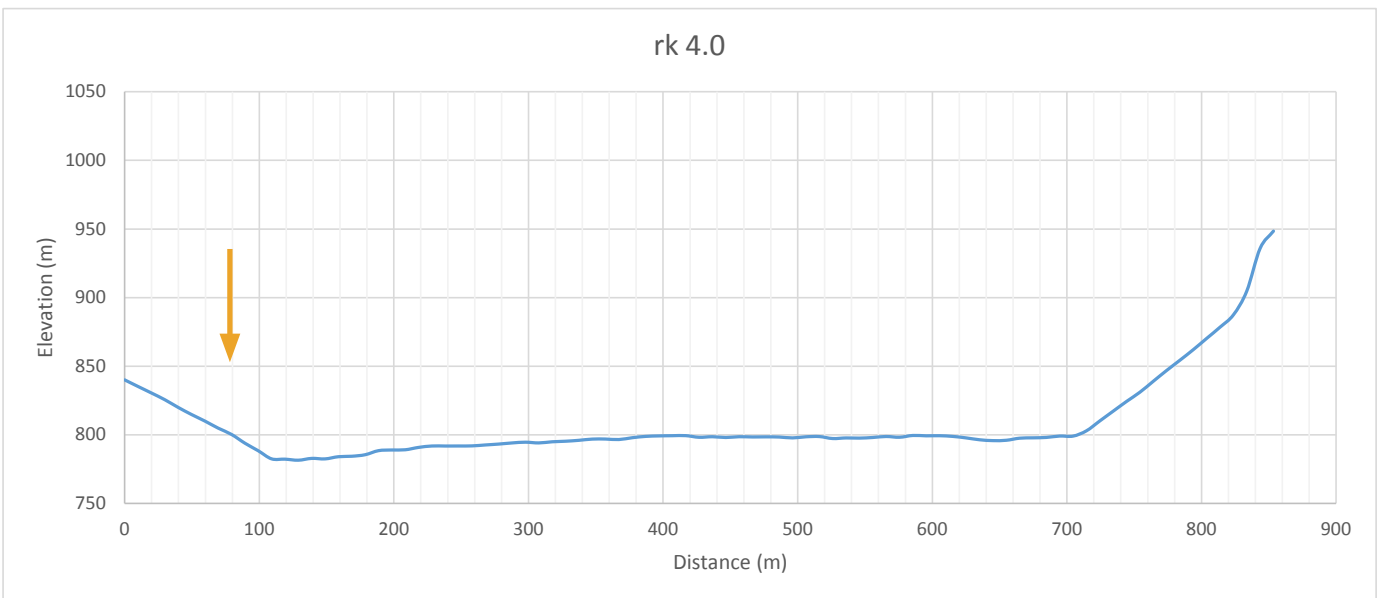
Figure 19: Cross-sectional profile sampled at river-kilometer 4.0. Orange arrow approximates position of thalweg.

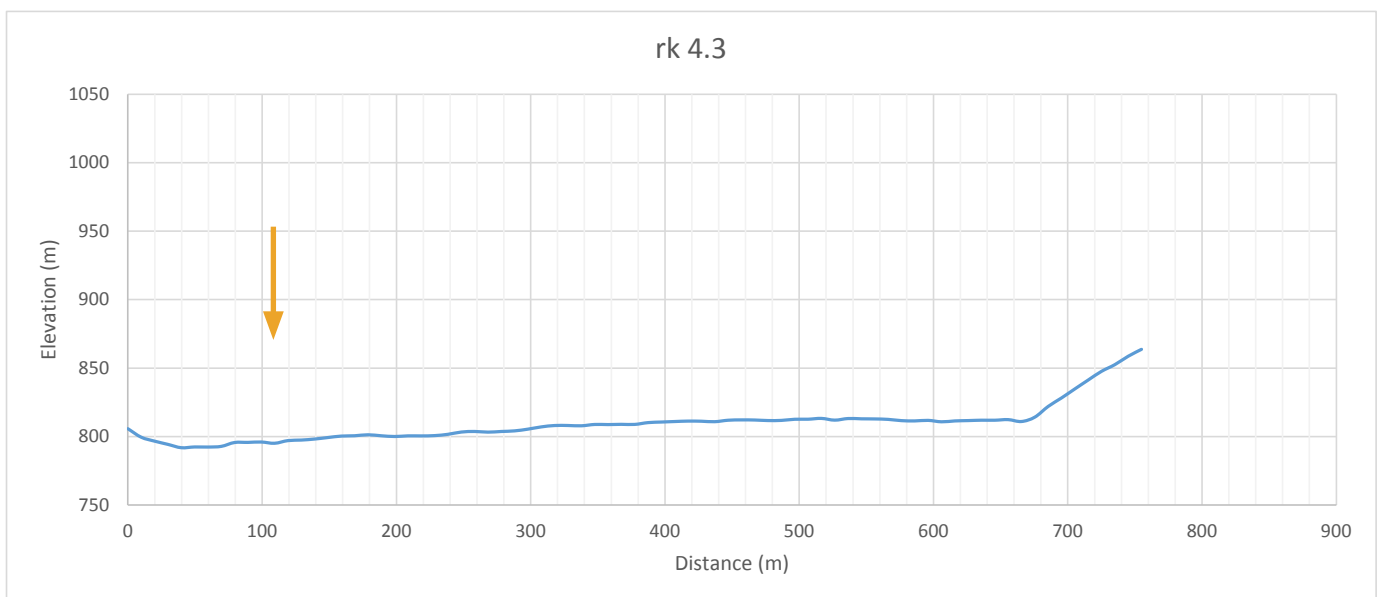
Figure 20: Cross-sectional profile sampled at river-kilometer 4.3. Orange arrow approximates position of thalweg.

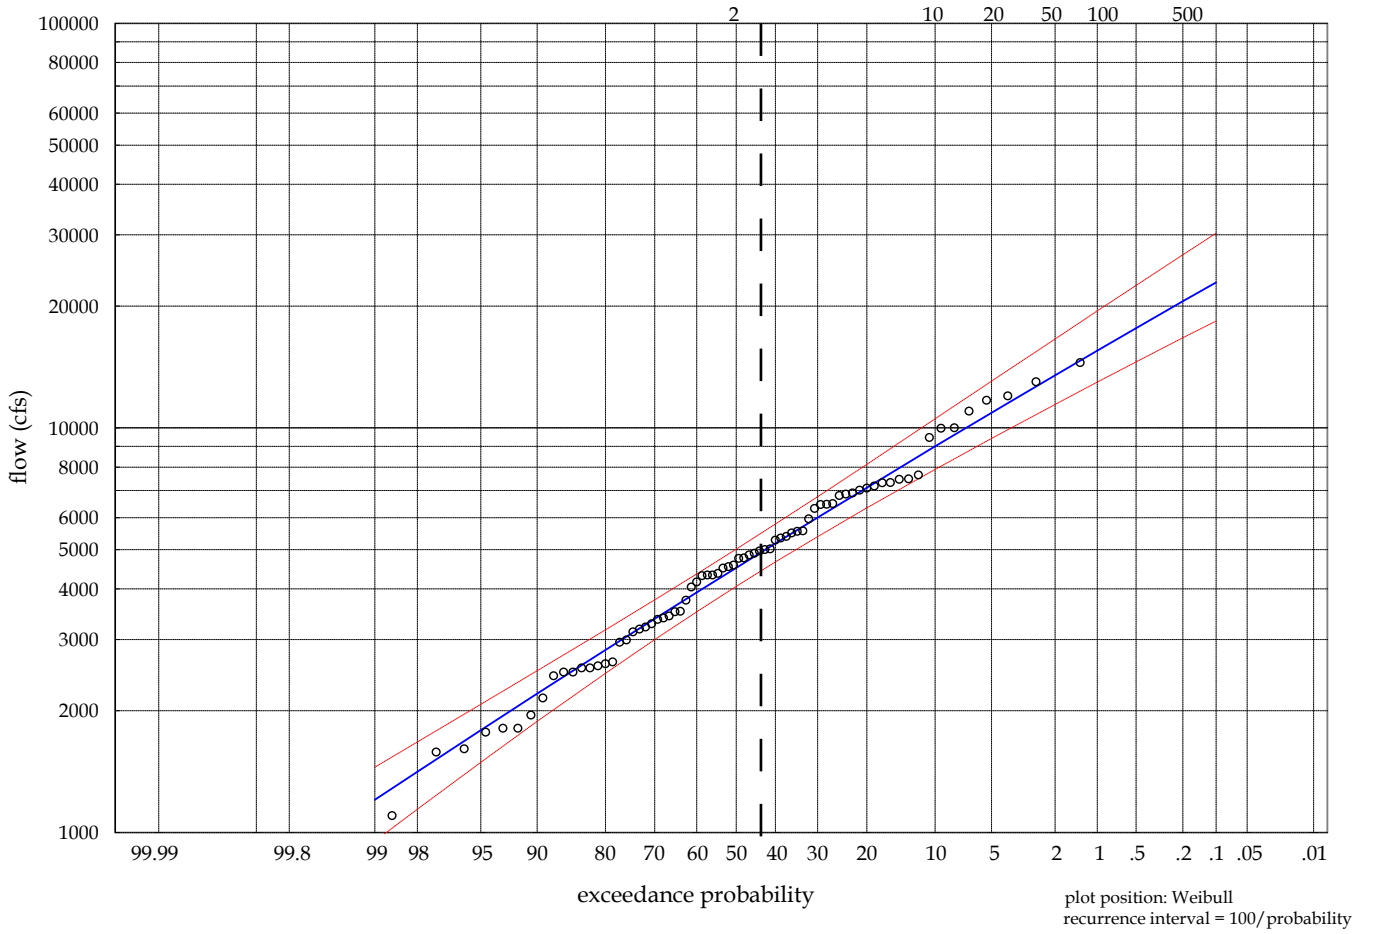
USGS 12094000 CARBON RIVER NEAR FAIRFAX, WA

Figure 22: Annual maximum series determined using Log Pearson III distribution. Dashed line shows 2015 winter flood event that created the fence jam at WF-13.

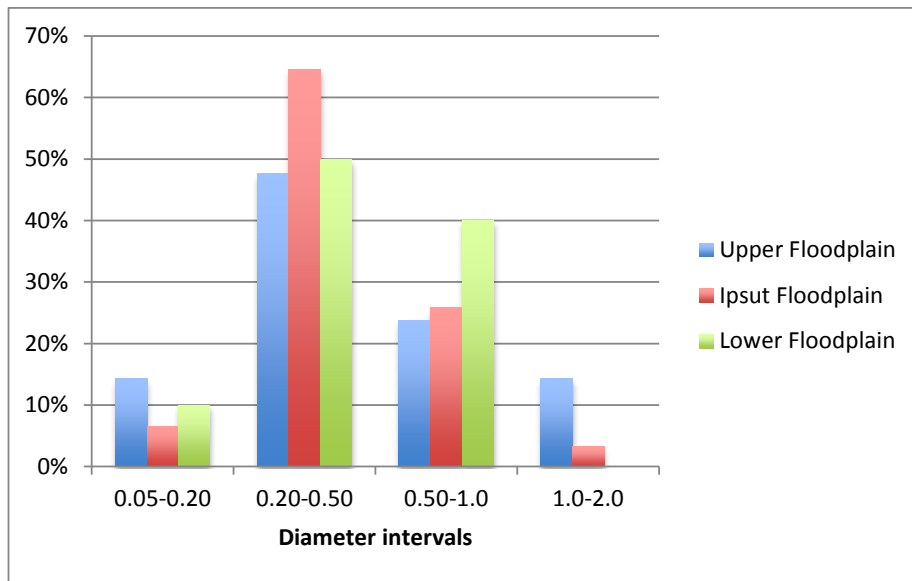
Figure 23: Normalized percentage of standing tree diameter at breast height (DBH) for the three sections of the River.
