THE ROLE OF LARGE WOODY DEBRIS AND RIPARIAN FOREST IN CHANNEL AVULSION IN THE CARBON RIVER, MOUNT RAINIER NATIONAL PARK, WA

Master of science
Earth and Space Sciences: Applied Geosciences

University of Washington
May, 2016

MESSAGE Technical Report Number: 037

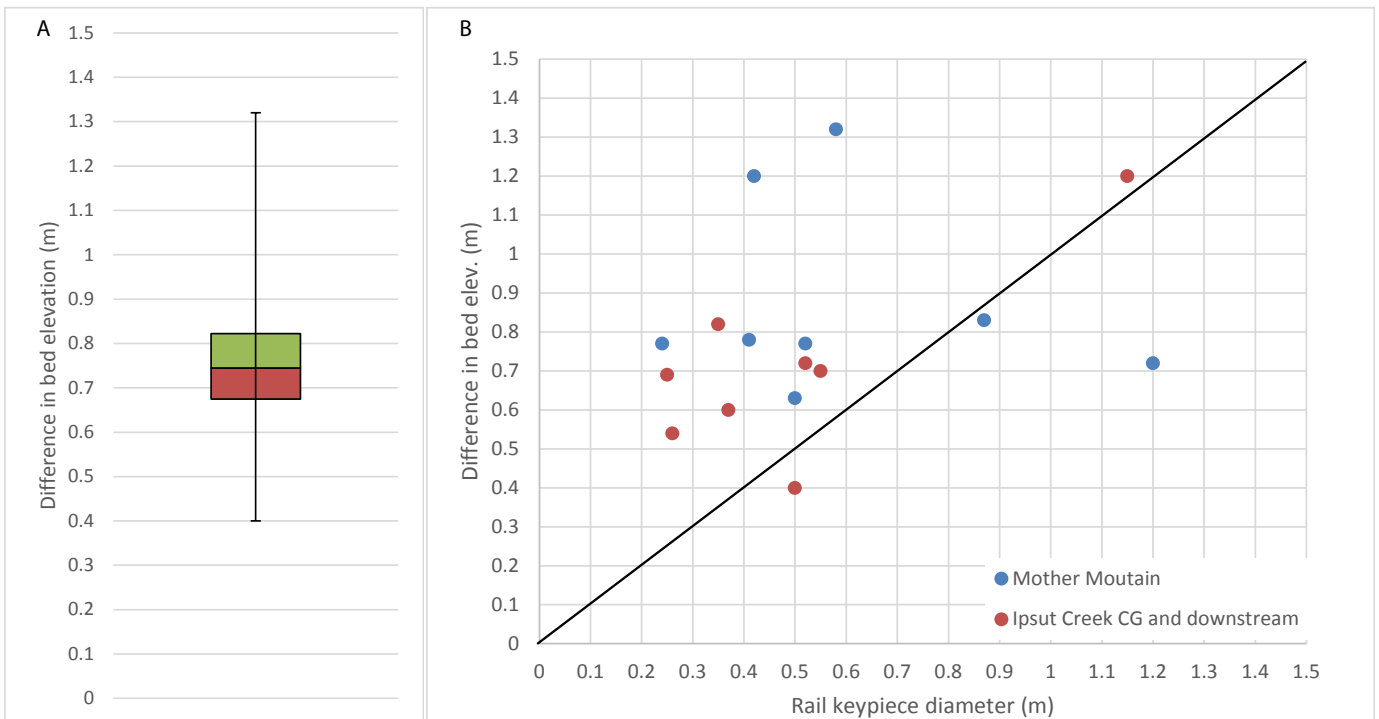
Figure 24: (a) Distribution of vertical bed-surface elevation change throughout all of the mapped fence jam. (b) Ratio of keymember WD (fence rail) diameter to the difference in bed elevation.

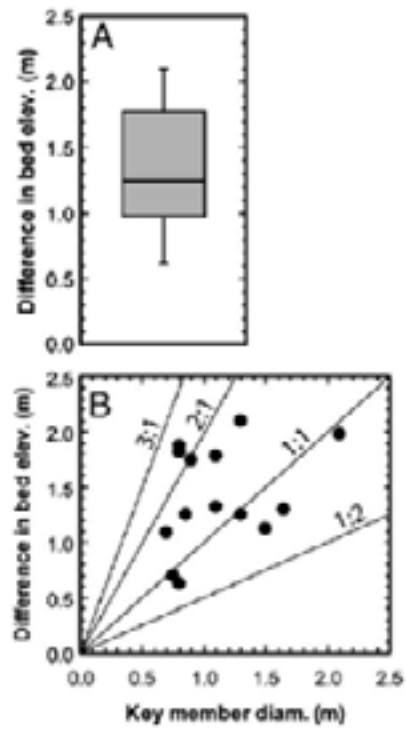
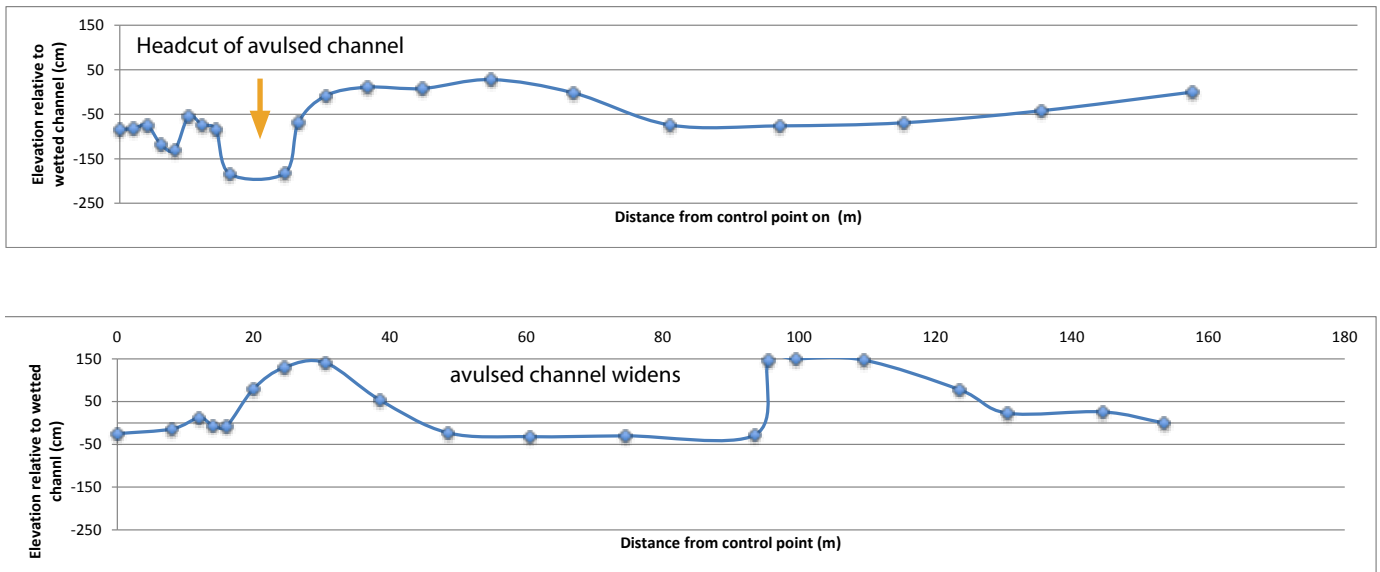
Figure 26: Cross sections measured at WF-13. (a) Cross section taken from valley wall (figure-left) to wetted channel (figure-right). (b) cross section taken 100 meter downstream from (a).

I surveyed two cross-sectional profiles at fence jam location WF-13 to show relative elevation of floodplain below the wetted main channel. Fence jam at this specific location is particularly interesting because it was formed between field reconnaissance in the summer of 2015 and field mapping in the spring of 2016. Thus, this was a fairly new feature that may be linked to the 2015 winter storm. Measuring a relative elevation change from adjacent floodplain to the wetted channel provided information on channel avulsion facilitated by the fence jam. The elevation profiles were measured using a hand level, a stadia rod, and a 50-foot measuring tape. The horizontal distance extended from an arbitrary datum (control point), set at the valley wall, to the edge of the wetted main channel. Cross section 1 is located at the initial control point (46.967869, -121.819176). Cross section 2 is located 50 meters downstream from the control point.

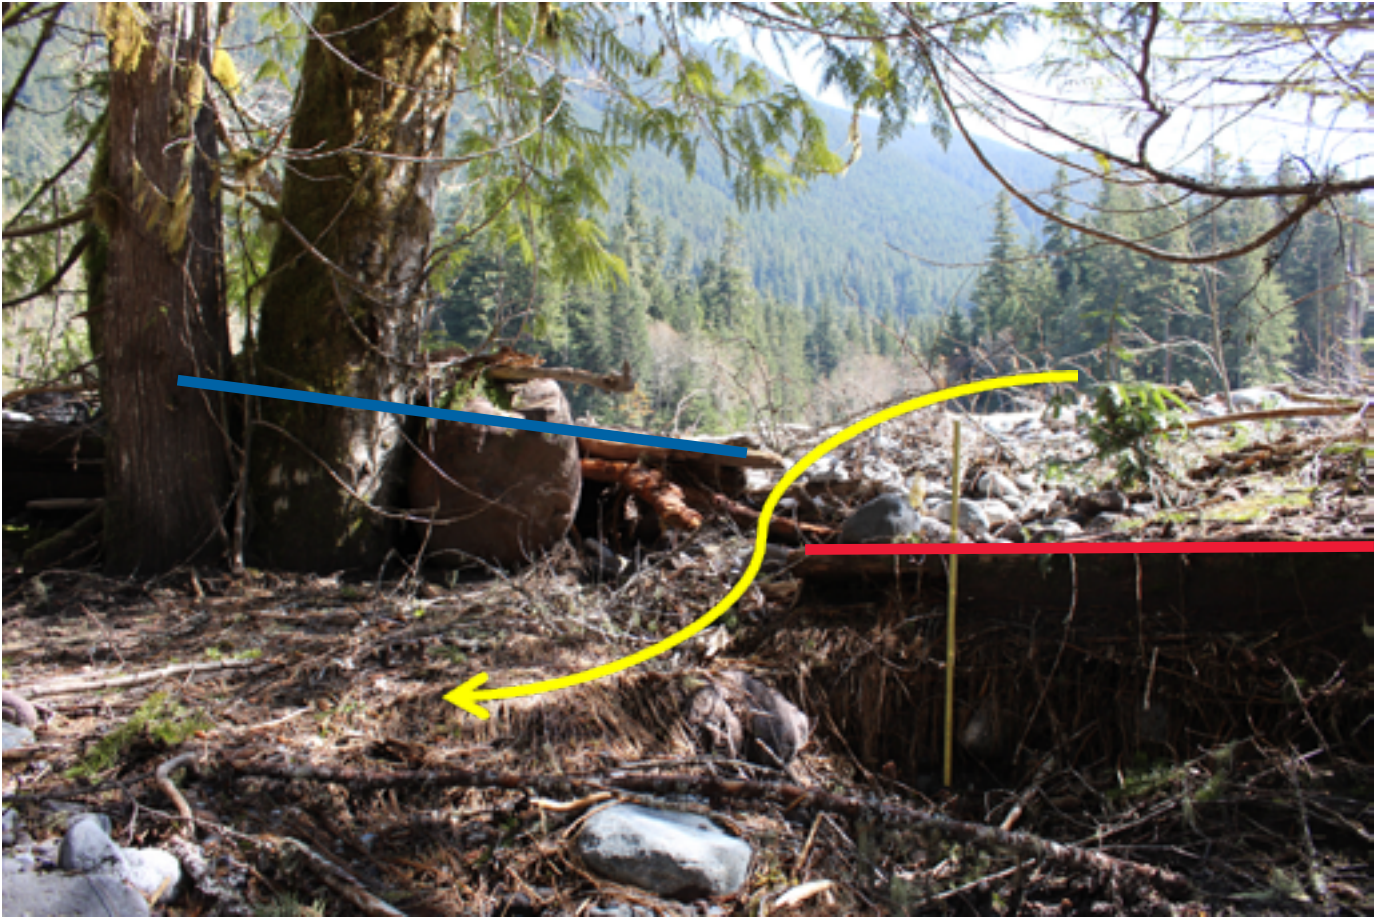
Figure 27: Two distinct fence jams (red and blue). Flow directed in between (yellow) at WF-20.

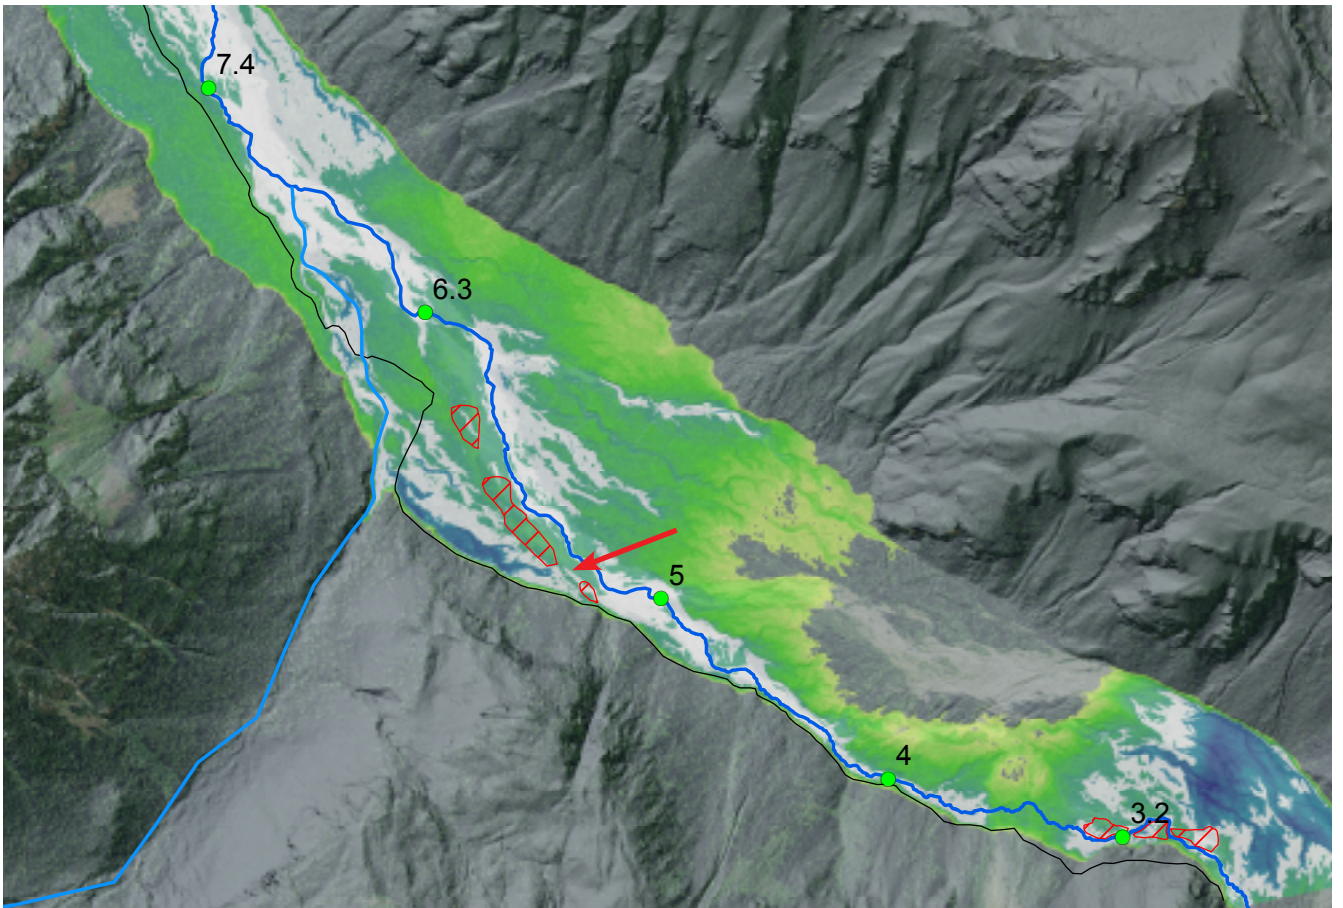
Figure 29: Potential avulsion pathway (red arrow) of secondary channel at Ipsute Creek Campground

At river-kilometer 5.5, RWSE shows secondary channel that avulsed into the Ipsut Creek during the 2006 flood event (Figure 28). This section of the Carbon River is extremely at risk for inundation during high flows, because the Carbon River Road and the Ipsut Creek Campground are located on the floodplain, at 5 to 6 meters below main channel water surface. I observed fence jams throughout the margin that facilitates small scale avulsion into the Ipsut Creek floodplain (Figure 29).
