Geomorphic Impacts of the
2013 Colorado Front Range Flood
on
Black Canyon Creek and North Fork Big Thompson River

Chelsey DeWitt

University of Washington
March 9th, 2016

MESSAGe Technical Report Number: 032

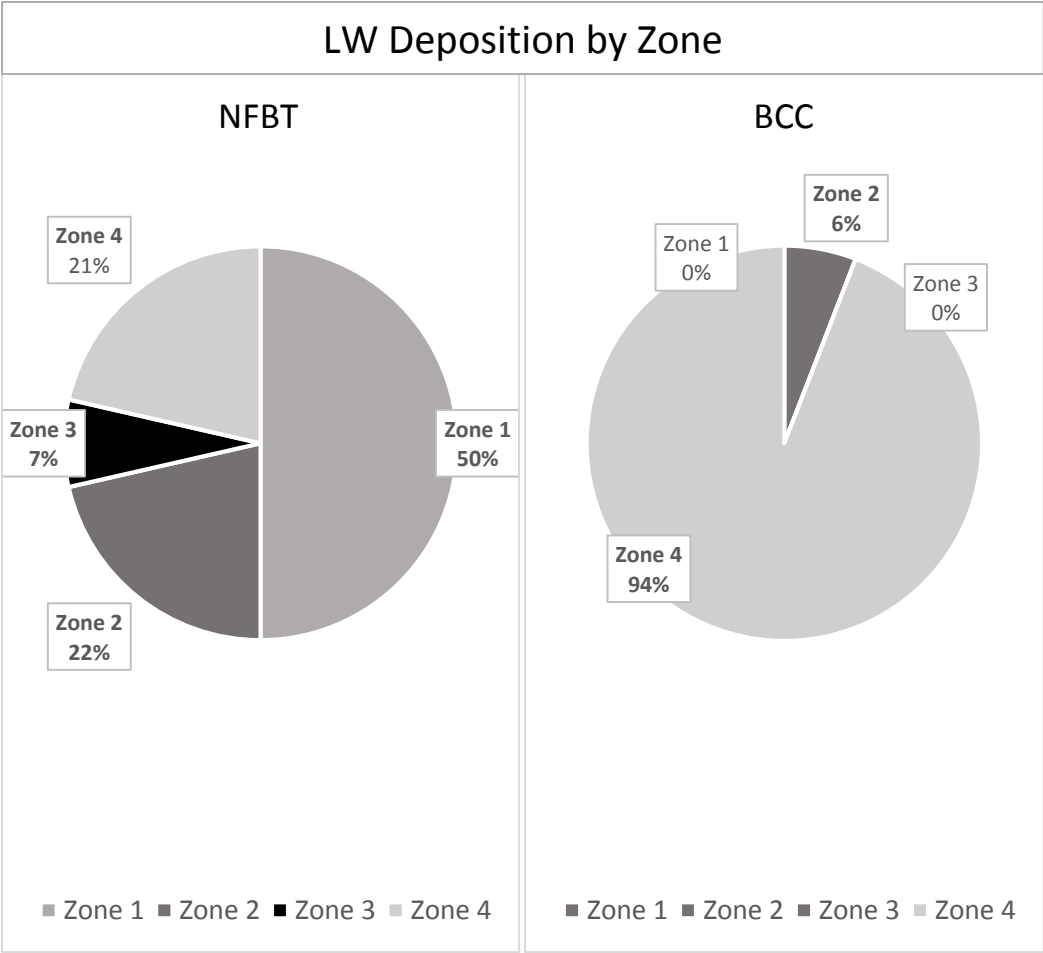
Figure 12. Large wood deposition by zone for BCC and NFBT. Zone criteria defined in Figure 11.

Large wood in BCC was predominantly deposited outside of the bankfull channel (Zone 4), whereas in NFBT, large wood accumulated within the wetted channel (Zone 1) (Figure 12). All LW jams in BCC are recorded outside of the bankfull channel, except one, located within the bankfull channel (Zone 2). Zone 4 jams accumulated behind alive and upright trees on the adjacent upland zones, terraces and eroded riparian zone (Figure 13). Half of the LW jams recorded in NFBT are located within the wetted channel (Zone 1). The remaining LW jams in NFBT are found within the bankfull channel (Zone 2), directly above (Zone 3) and outside the bankfull channel (Zone 4). In NFBT, wood located in the wetted channel accumulated behind stable, upright trees on mid-channel bars, or trail bridges (Figure 14). Some jams were comprised of a mixture of trail bridge infrastructure and transported wood.

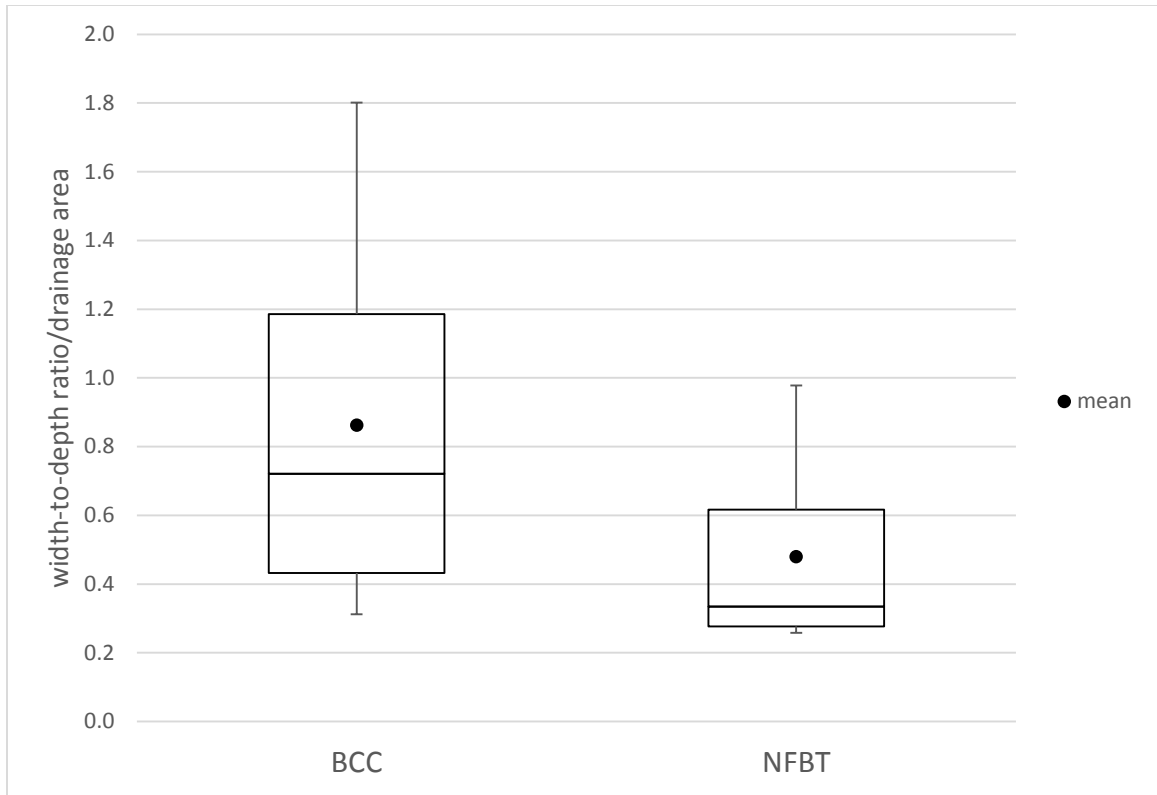
Figure 15. Width-to-depth ratio normalized by drainage area. Whiskers represent the range of data from maximum to minimum value. The box shows the interquartile range of the data. The upper box is 75th percentile and the lower box is the 25th percentile. The line within the box is the median.

BCC has a greater mean, and wider range in width-to depth ratio normalized by drainage area (Figure 15). The mean value is almost double in BCC than in NFBT, at 0.9 versus 0.5, and the data set for BCC ranges from 0.3 to 1.8 and from 0.3 to 0.9 in NFBT. These results are connected to the variance in channel cross-section widths, as cross-section depth were a similar value throughout the study area. In BCC, two cross-sectional widths in Reach 5 are much greater than

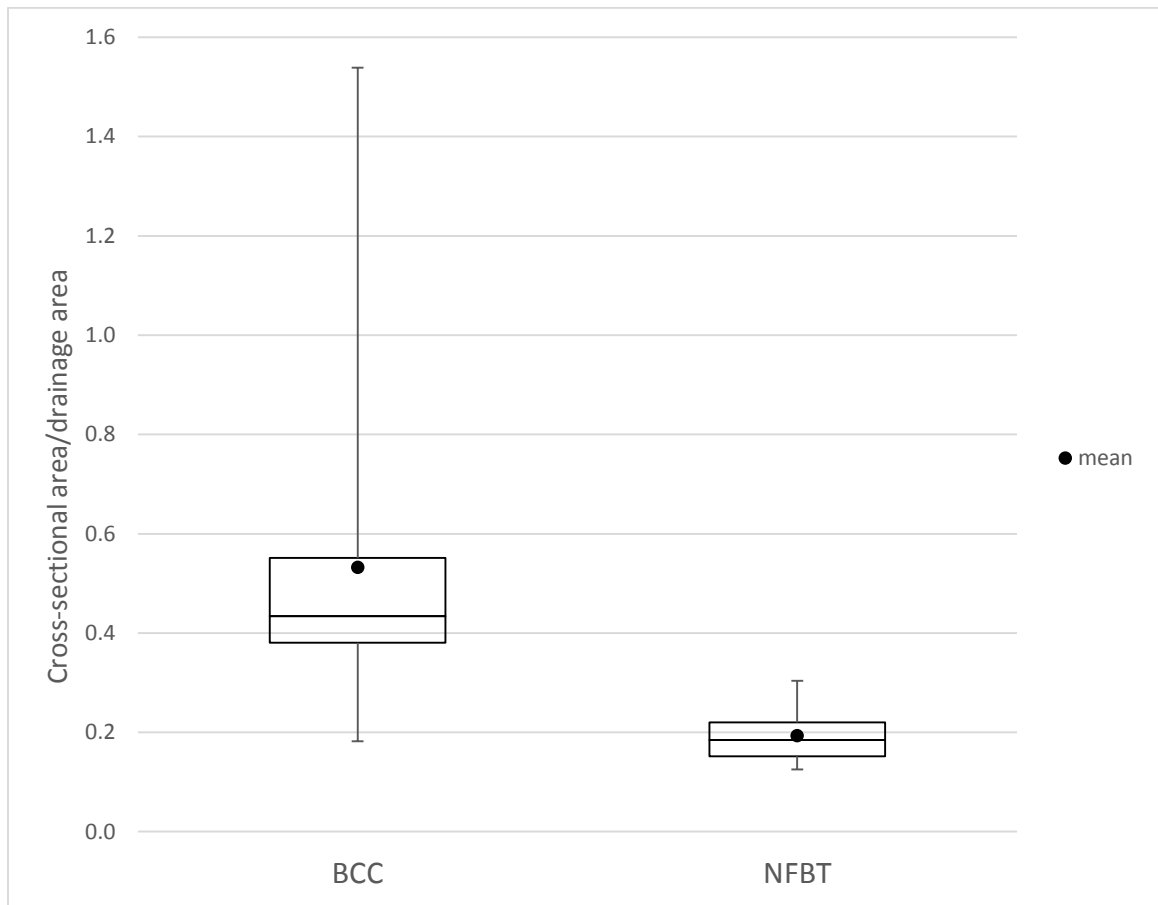
Figure 16. Cross-sectional area normalized by drainage area. Whiskers represent the range of data from maximum to minimum value. The box shows the interquartile range of the data. The upper box is 75th percentile and the lower box is the 25th percentile. The line within the box is the median.

The normalized cross-sectional area mean and range in data is greater in BCC than NFBT (Figure 16). On average, the normalized cross-sectional area for BCC was 2.5 times greater than values for NFBT, at 0.5 versus 0.2, and the data set for BCC ranges from 0.2 to 1.5 and from 0.1 to 0.3 in NFBT. Most of the values for normalized cross-sectional area in BCC concentrate around 0.4, but is greatest at the debris flow and stream confluence with a value of 1.5 (Table 5). The cross-sectional area at the confluence was approximately three times greater than the areas at the other cross-sections. Standard deviation for BCC is 0.4 and 0.1 for NFBT (two-sample t-test, $p=0.01$).
